## Preliminary Earthquake Reconnaissance Report: Türkiye Earthquake Sequence on February 6, 2023

### Field Assessment Team Lead

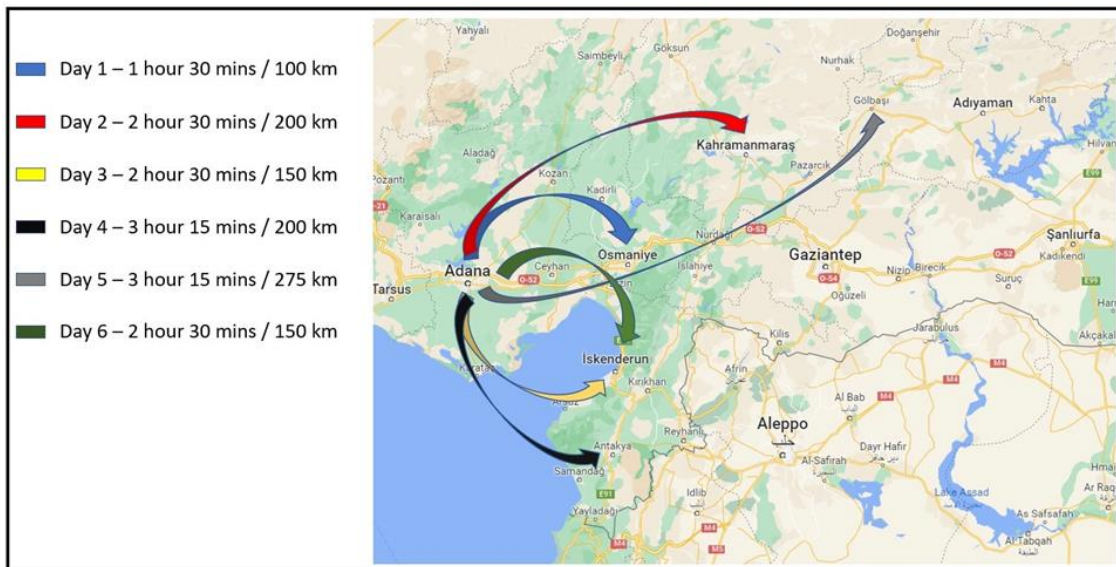
Figure 1-1 Route for Reconnaissance Tour

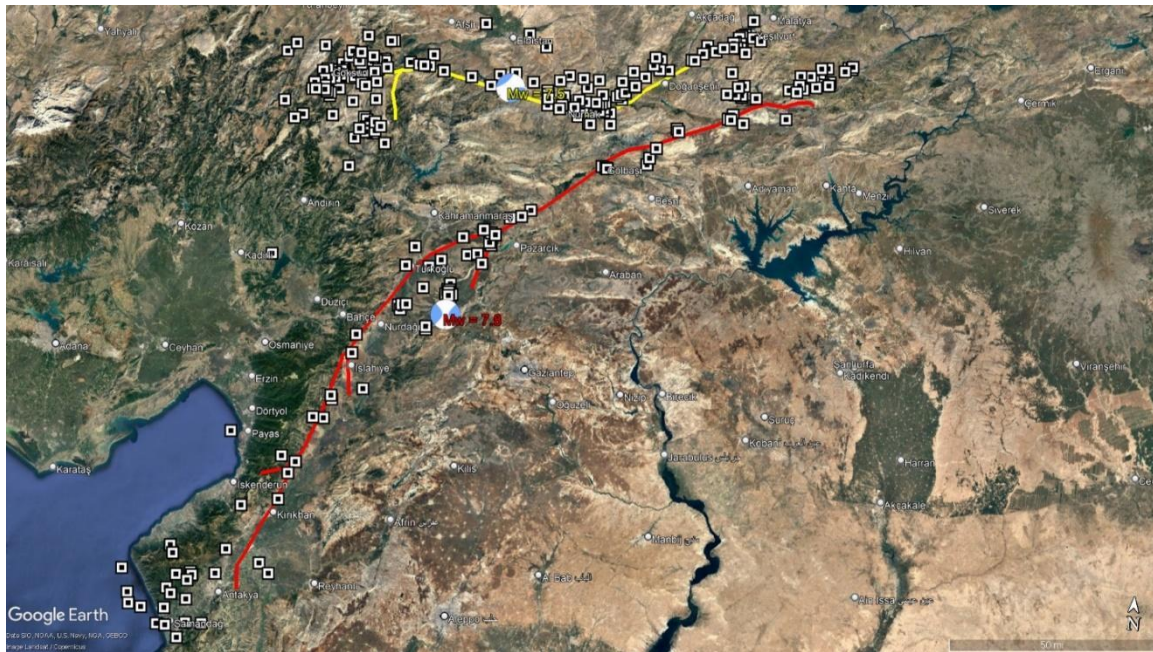
Figure 2-1 The fault ruptures and epicenter locations of  $M_w$  7.8 and  $M_w$  7.5 earthquakes (The beach ball diagrams representing the focal mechanism were downloaded from USCS (2023a) and USCS (2023b)) along with the aftershocks.

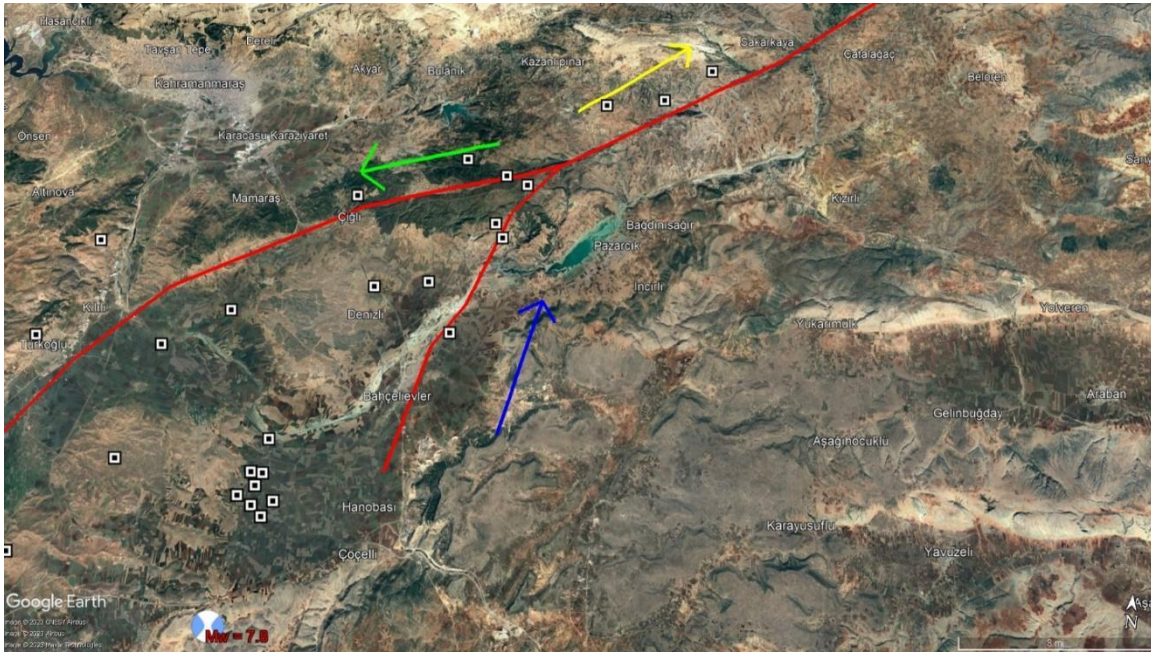
Figure 2-2 The fault rupture propagation of  $M_w$  7.8 earthquake

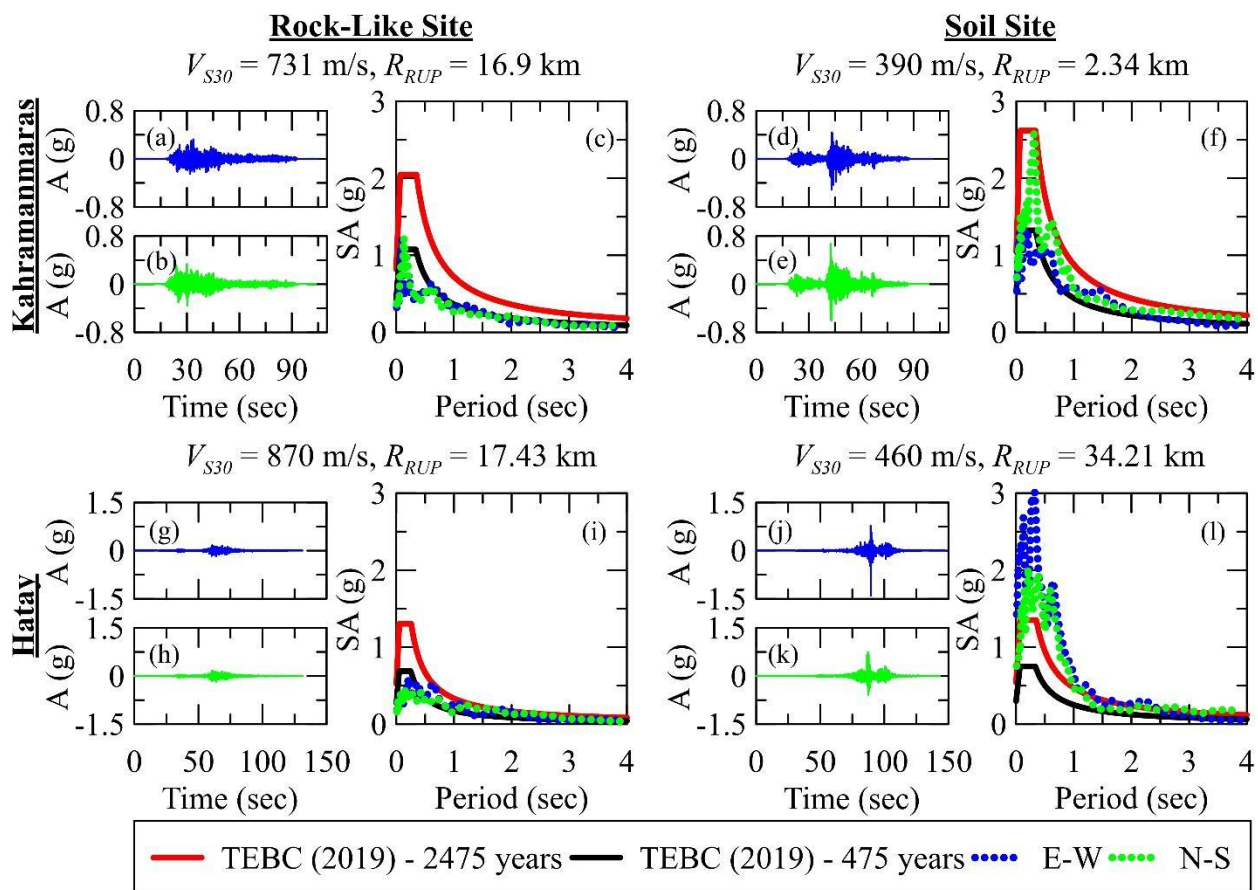
Figure 2-4 The baseline corrected acceleration (A) time histories in (a) E-W, (b) N-S directions, and (c) 5% damped response spectral accelerations (SA) and design spectra suggested by TEBC (2019) for return periods of 2475 years and 475 years for station ID of 4611 located in Kahramanmaraş. The same information is presented for (d, e, f) station ID of 4616, (g, h, i) station ID (Hatay) of 3116, and (j, k, l) station ID (Hatay) of 3135 ( $M_w = 7.8$  event).

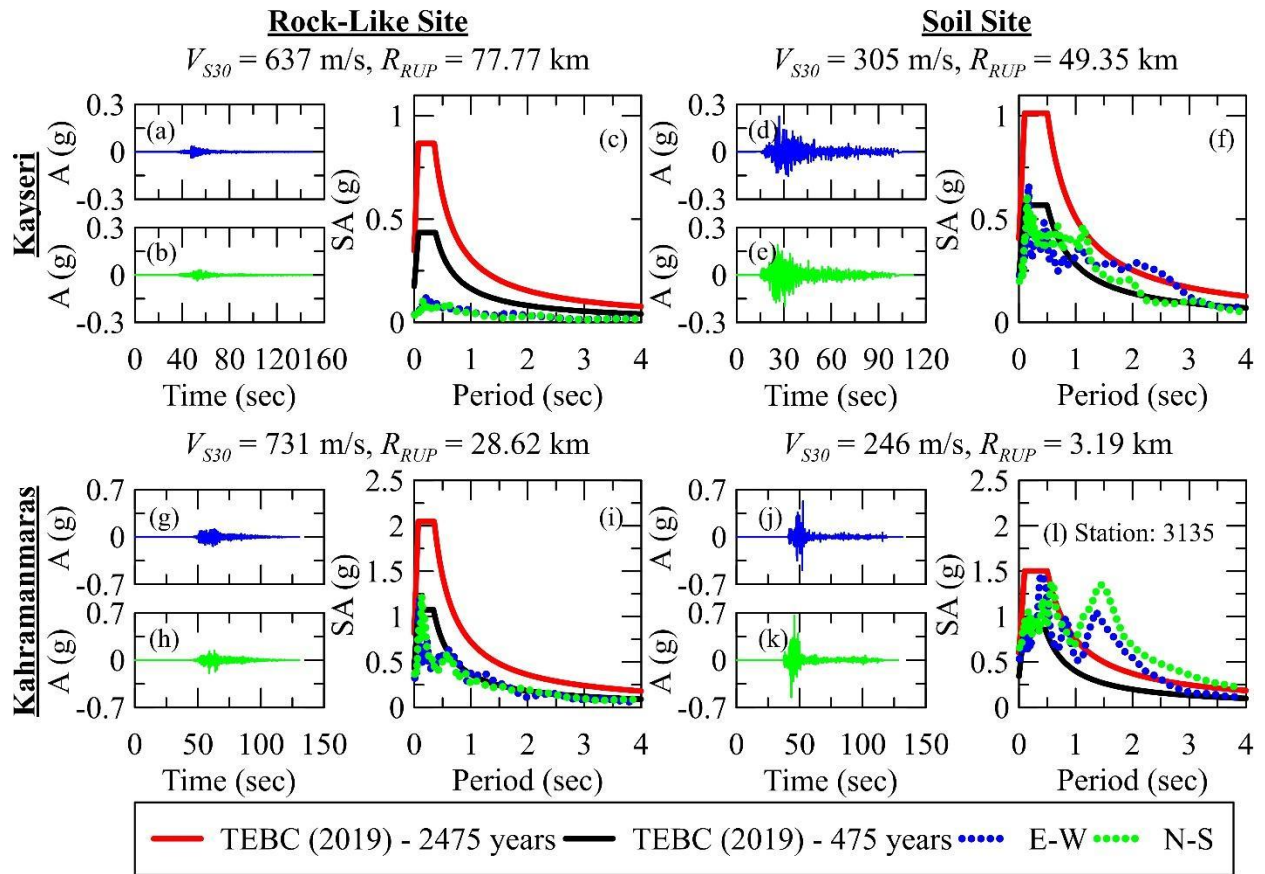
Figure 2-5 The baseline corrected acceleration (A) time histories in (a) E-W, (b) N-S directions, and (c) 5% damped response spectral accelerations (SA) and design spectra suggested by TEBC (2019) for return periods of 2475 years and 475 years for station ID of 3804 located in Kayseri. The same information is presented for (d, e, f) station ID of 3802, (g, h, i) station ID (Kahramanmaras) of 4611, and (j, k, l) station ID (Kahramanmaras) of 4612 ( $M_w = 7.5$  event).

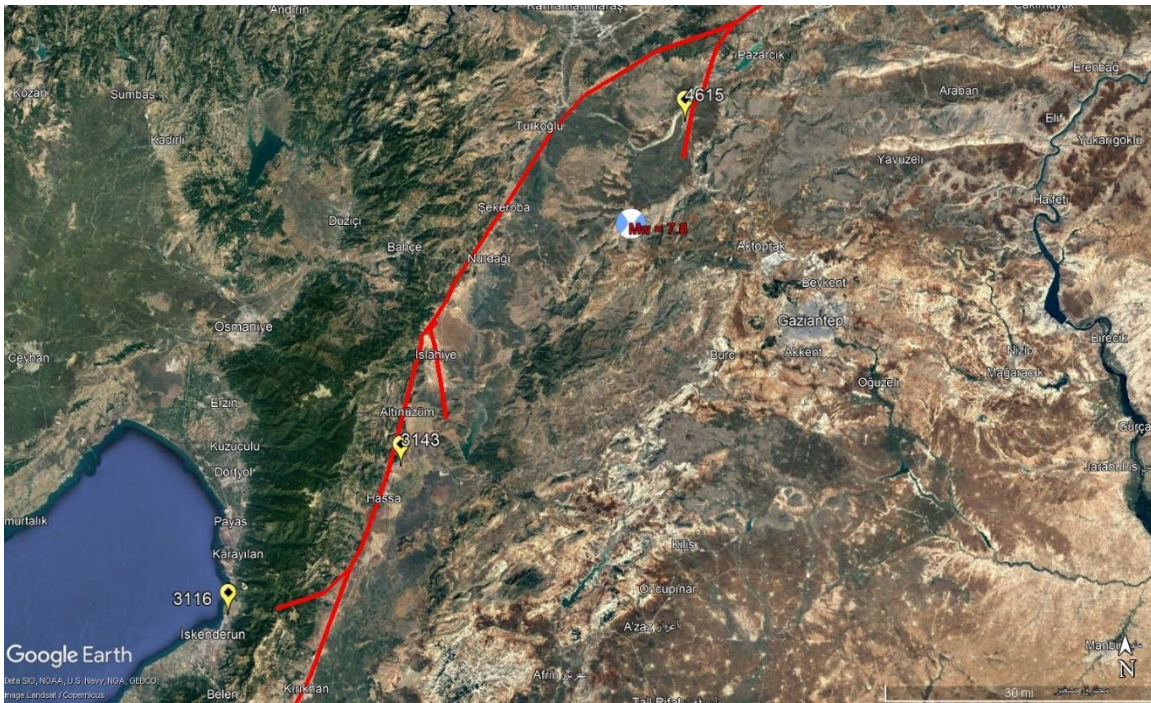
Figure 2-6 Station 3116, 3143 and 4615 along with the fault rupture in  $M_w$  7.8 event.

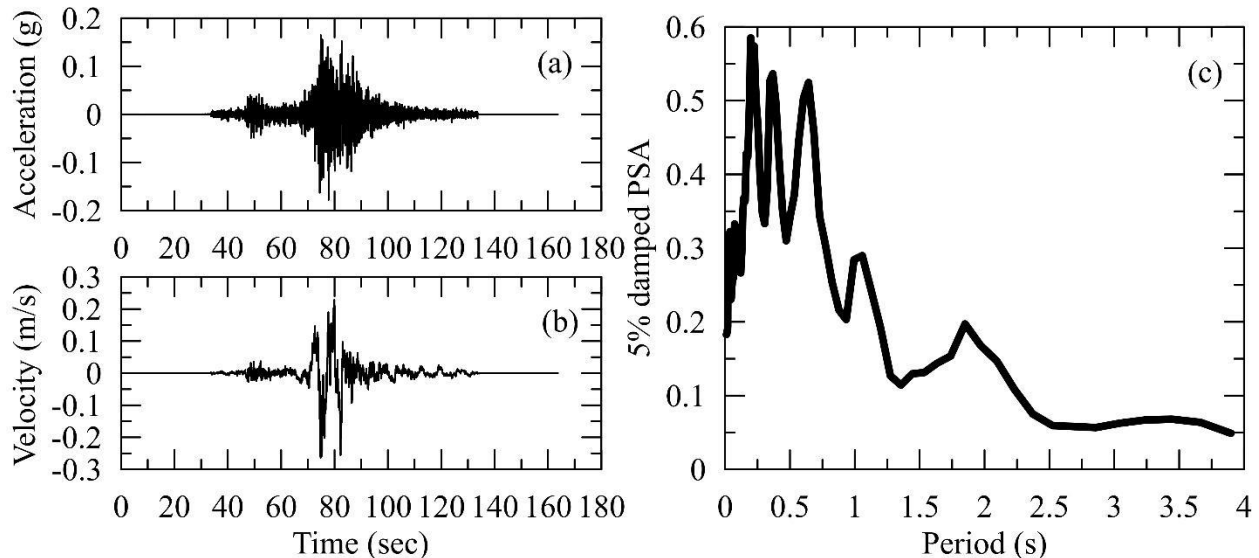
Figure 2-7 The (a) acceleration and (b) velocity time histories, and (c) pseudo-spectral acceleration of Station 3116 (Hatay) for  $M_w$  7.8 event.

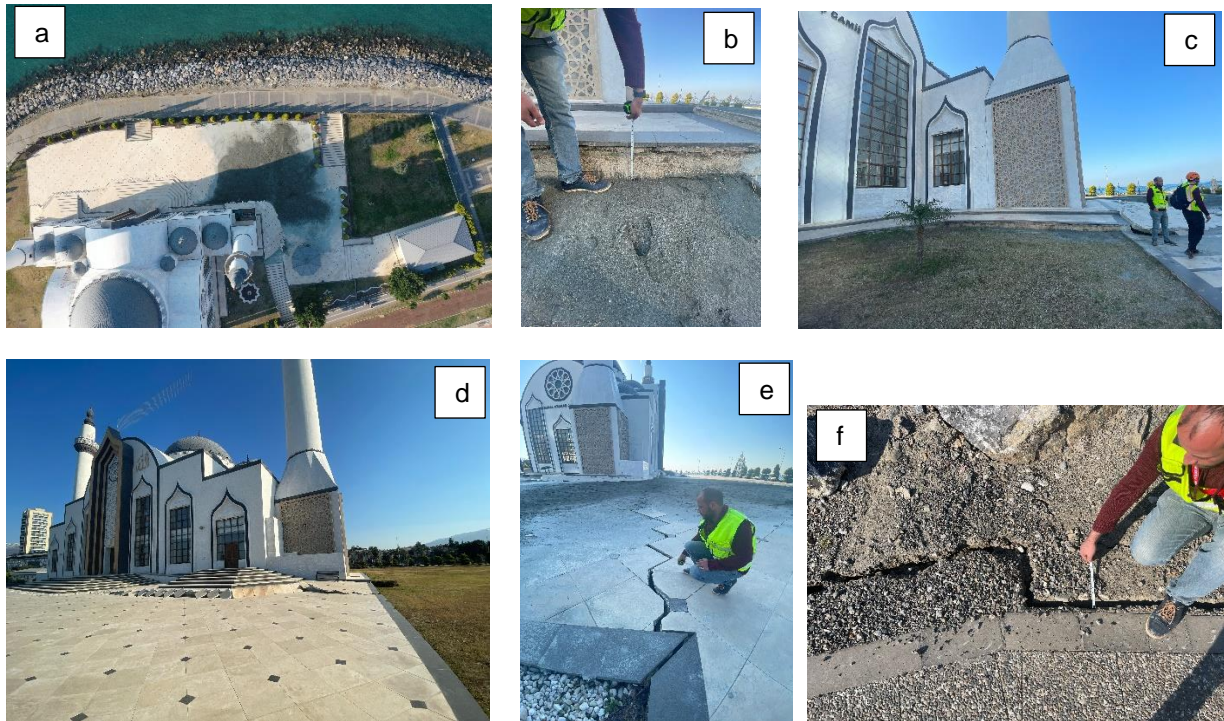
*Figure 3-2 Liquefaction manifestations in Nihal Atakas Mosque (~ 36°35'35.27"N/ 36° 9'26.74"E): a) Bird's-eye view of the sand ejecta at the corner; b) settlements of the sand near the mosque; c) front view outlining the settlements; d) severe deformations observed on the marble ground due to liquefaction induced settlements; e) lateral spreading in front of the mosque; f) lateral spreading near the mosque towards the sea.*

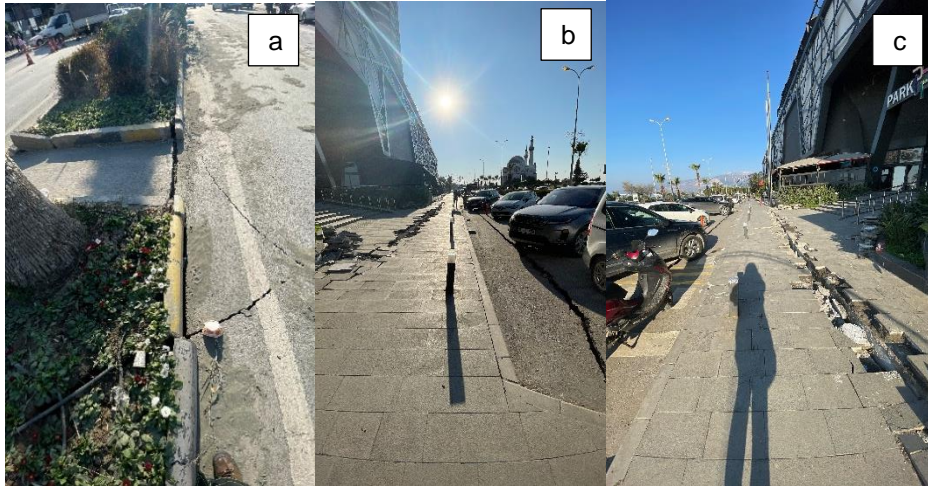
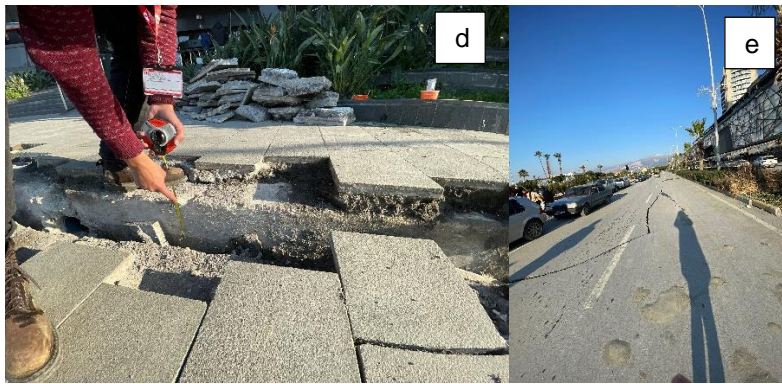
Figure 3-3 Liquefaction manifestations on Ataturk Boulevard near Forbes Shopping Center (~ 36°35'36.52"N/ 36° 9'34.67"E): a) sand boils on Ataturk Boulevard; b) cracks formed due to lateral deformation; c) cracks formed due to lateral deformation; d) liquefaction induced settlements; e) cracks formed due to lateral deformation.

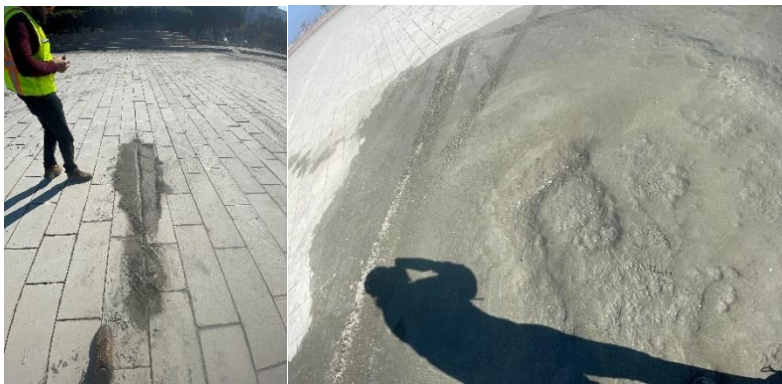
Figure 3-4 Liquefaction manifestations (sand boils) on Ataturk Boulevard near Ataturk (~ 36°35'29.50"N/ 36° 10'20.23"E)

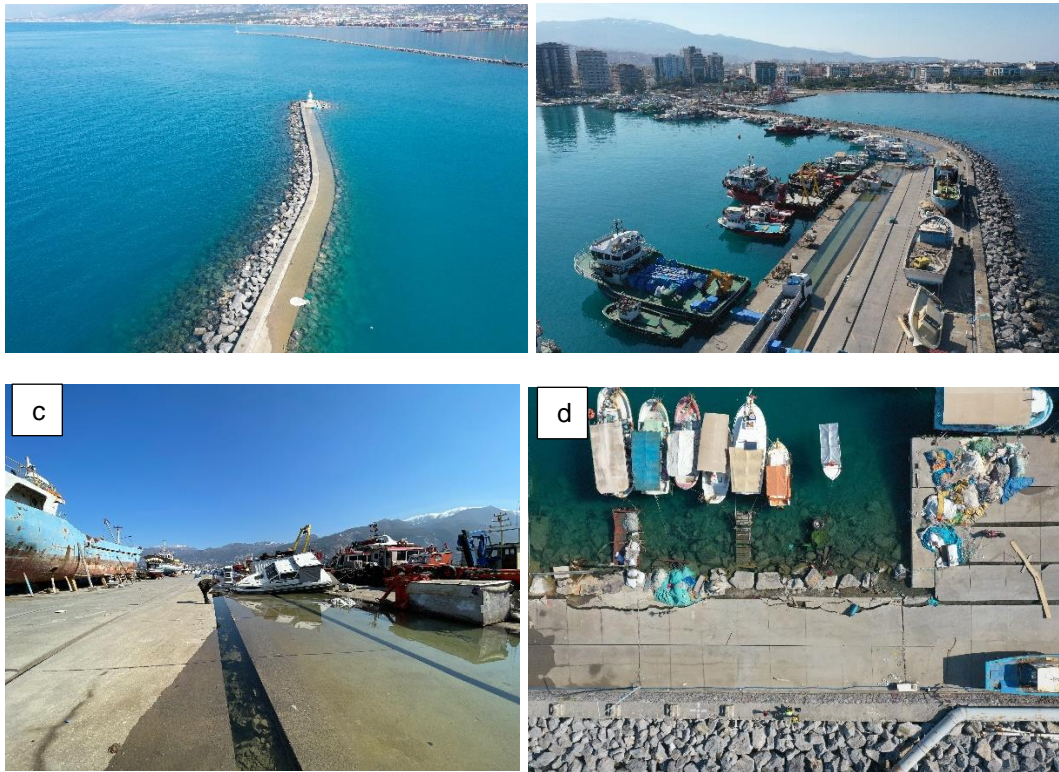
Figure 3-8 Ground Settlements and Lateral Deformations on Iskenderun Dock (~ 36°35'40.67"N/ 36° 10'38.69"E): a) Ground subsidence at the pier and the lighthouse; b) Ground subsidence at the dock; c) Ground subsidence and lateral deformations of the concrete panels; d) lateral deformations and cracks on the concrete panel

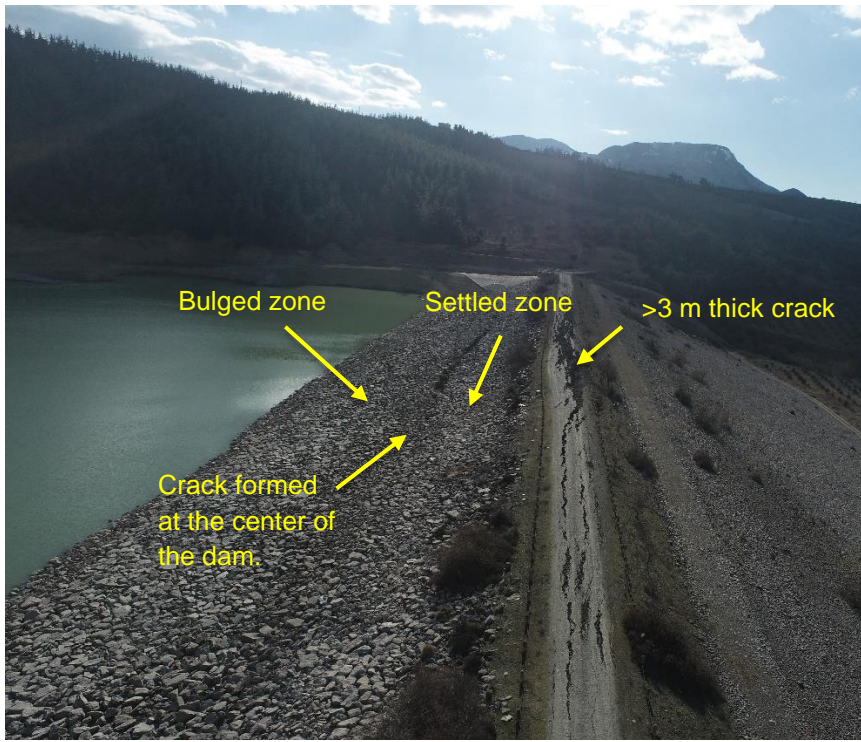
The Arıklıkış Dam is a homogenous earth-fill dam constructed between 1994-1998 in Osmaniye for irrigation purposes. The crest height from the stream level is almost 32 meters. Cracks were formed during the earthquakes at the crest level, and the crack widths range between 2.2 m and 4 m. Lateral movement is toward the upstream, and no damage was detected on hydraulic structures except for minor cracks on the curtain walls of the spillway. In addition, the face of the dam at the upstream side was observed to be significantly settled close to the crest and bulged out towards the toe of the dam with a visible opening at the center of the slope (see Figure 3-10 for the photos).

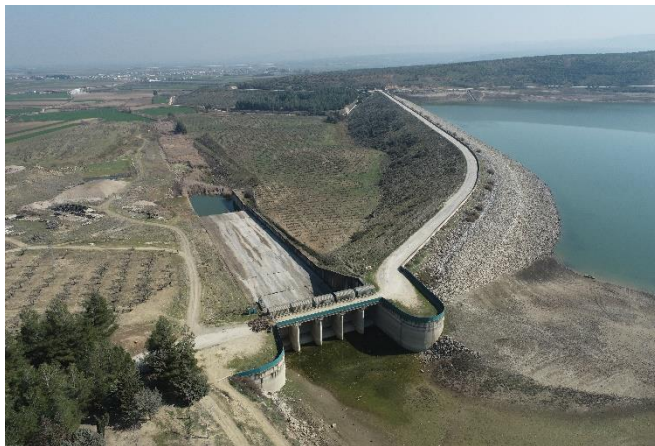
The Yarseli Dam is an earth-fill dam constructed between 1985-1991 in Antakya for irrigation purposes. The crest height from the stream level is almost 37 meters [Figure 3-11(a)]. Crest cracking with lateral displacements vary between 0.15-0.25 m, as can be seen in Figure 3-11(b). There were no sand boils on the earth-dam surface, so no trace of liquefaction was found. The hydraulic structures had no obvious cracking or damage.

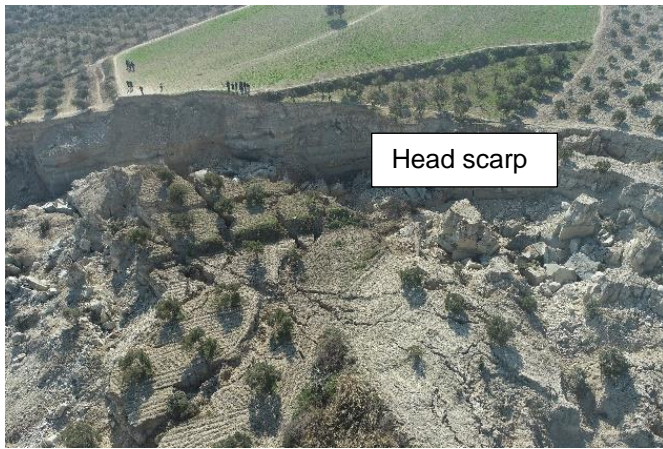
The slope angle ranges from 10 to 30 degrees. The area had been particularly dry for several years, but there was a heavy rainfall that lasted for several days preceding the earthquakes, inundating and saturating the soil. Figure 3-12 presents aerial photos taken at the slope instability area.

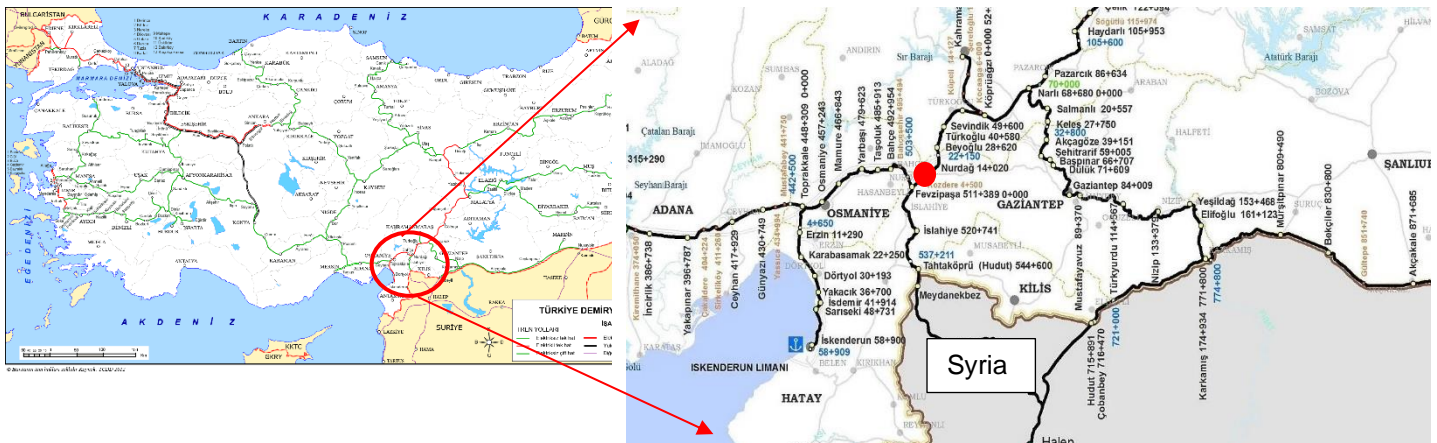
Figure 3-13 Overview map of the railroad map of Türkiye-Syria and landslide location (~ 37°06'43.41"N/ 36° 39'34.91"E)

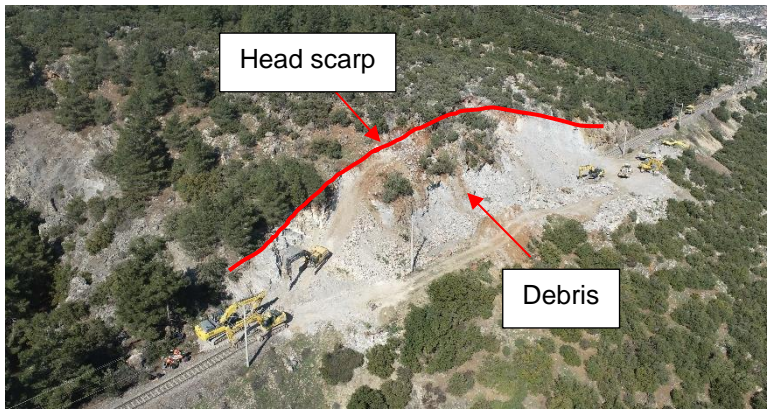
The collected data is not enough to report if the landslide was caused by the first or second earthquake in the sequence. Aerial footage of the landslide indicates that the head scarp is approximately 100 meters long. Several backhoes were immediately sent to the site for debris removal.

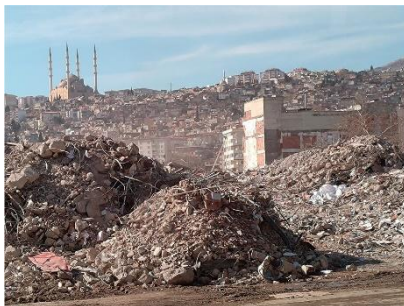
City	Damage Level					
	None	Slightly	Others	Extensive	Partial Collapse	Full collapse
Adana	72.11	21.71	5.51	0.51	0.05	0.12
Adiyaman	29.9	32.54	14.58	15.9	1.85	5.23
Diyarbakir	59.79	24.2	13.55	1.85	0.14	0.47
Gaziantep	59.7	18.27	15.42	4.35	0.71	1.55
Hatay	49.47	23.54	7	13.36	2.31	4.32
Kahramanmaras	37.75	28.69	14.75	12.43	2.66	3.72
Kilis	50.39	31.39	9.31	5.83	0.78	2.29
Malatya	26.12	26.89	20.65	21.57	0.63	4.13
Osmaniye	63.98	20.98	8.34	5.66	0.58	0.46
Sanliurfa	49	34.85	15.16	0.78	0.09	1.3

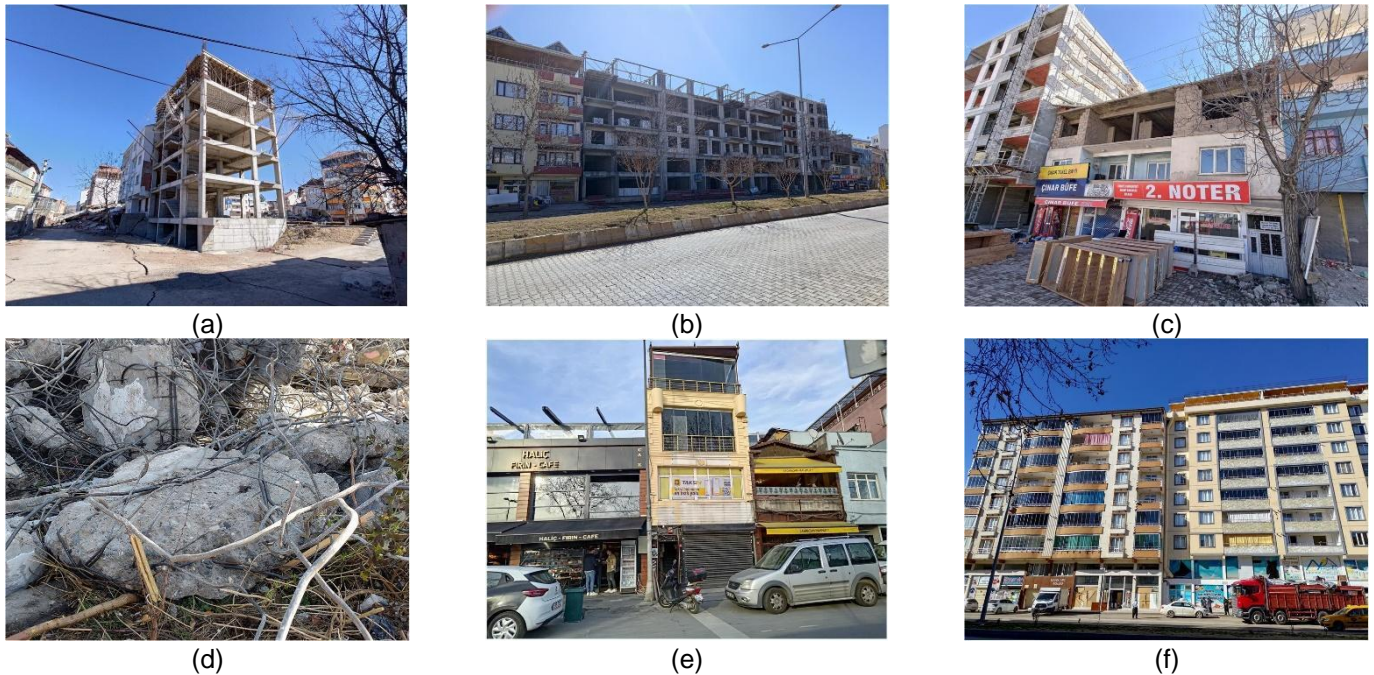
Figure 4-2 (a) and (b) two buildings with different construction practices, (c) a building with an added third story, (d) poor concrete and plain reinforcement, (e) and (f) no separation between buildings.

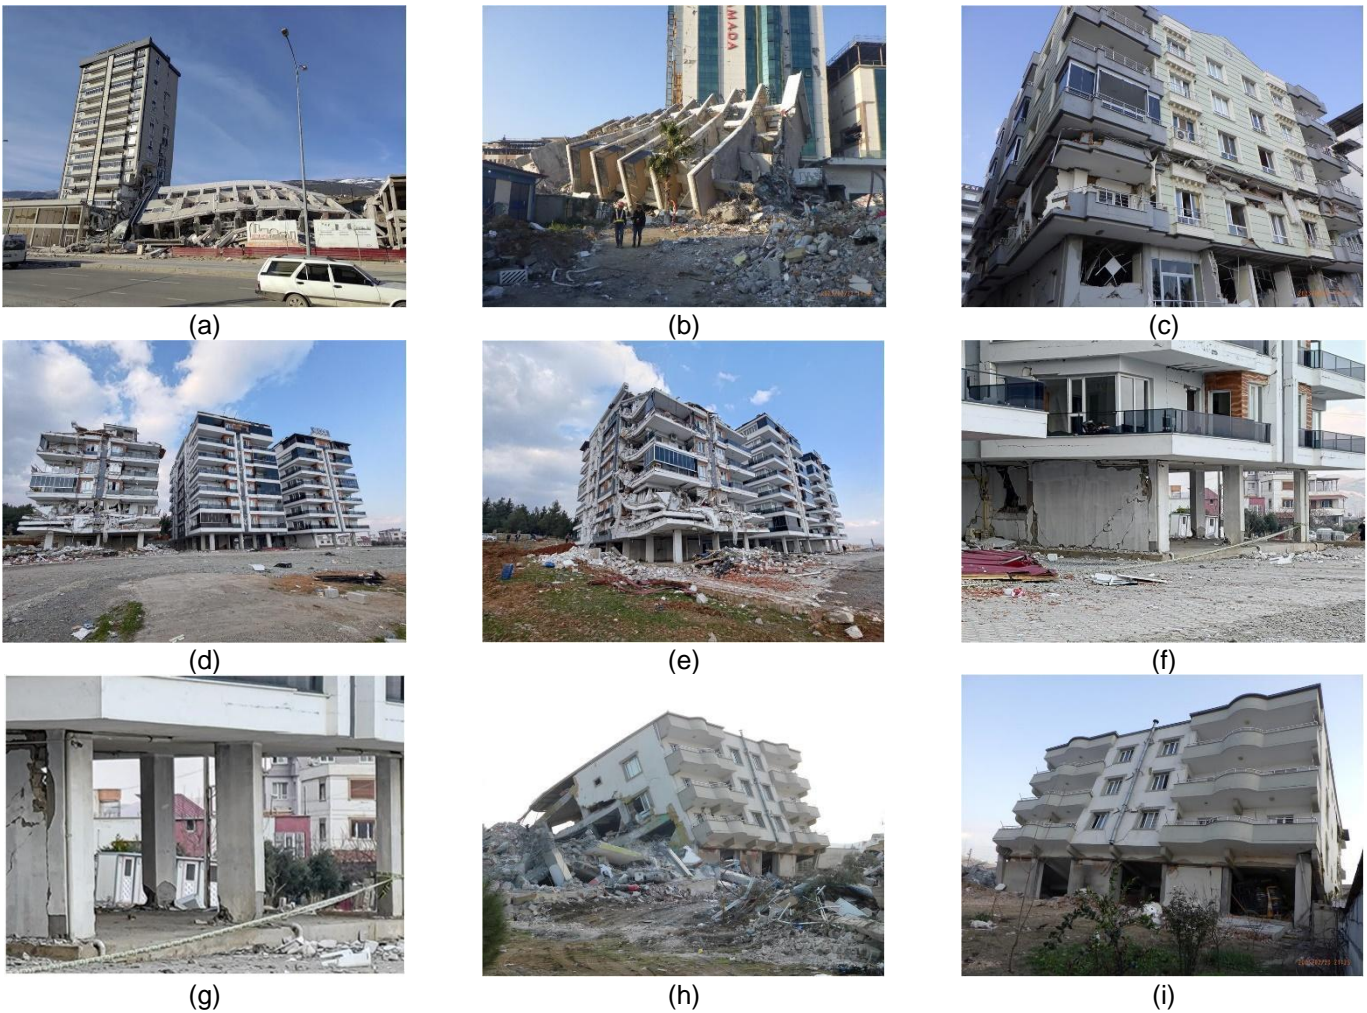
Figure 4-3 (a) and (b) lie-down collapsed buildings, (c) a building with pancaked third story, (d) and (e) three similar buildings with different damage states, (f) close-up photograph of the first story of the right building, (g) bi-directional and one-directional plastic hinges, (h) and (i) a knee-down collapsed building.

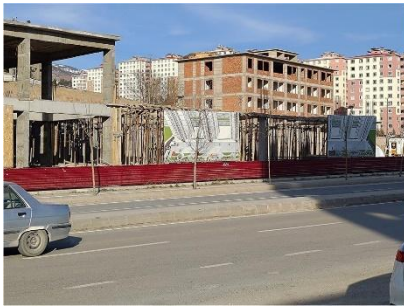
Figure 4-5 Structural damages (a) and (b) collapsed buildings along a significantly weak direction; (c) plastic hinges at top and (d) plastic hinges at bottom of columns, (e) an almost intact building, and (f) a close-up photograph of (e).

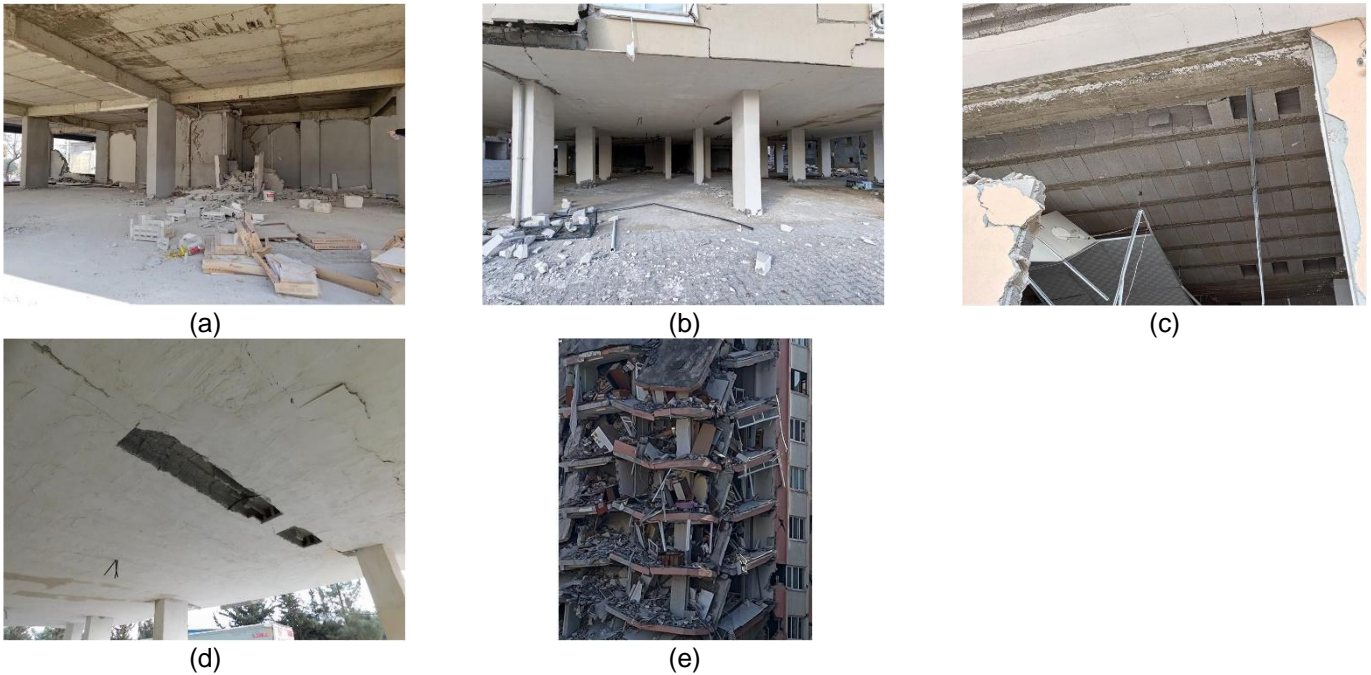
Figure 4-7 A floor slab system (a) supported by beams and columns, (b) directly supported by columns, (c) and (d) bricks of the no-beam slab system fallen down, (e) a building with the no-beam slab system was under demolition.

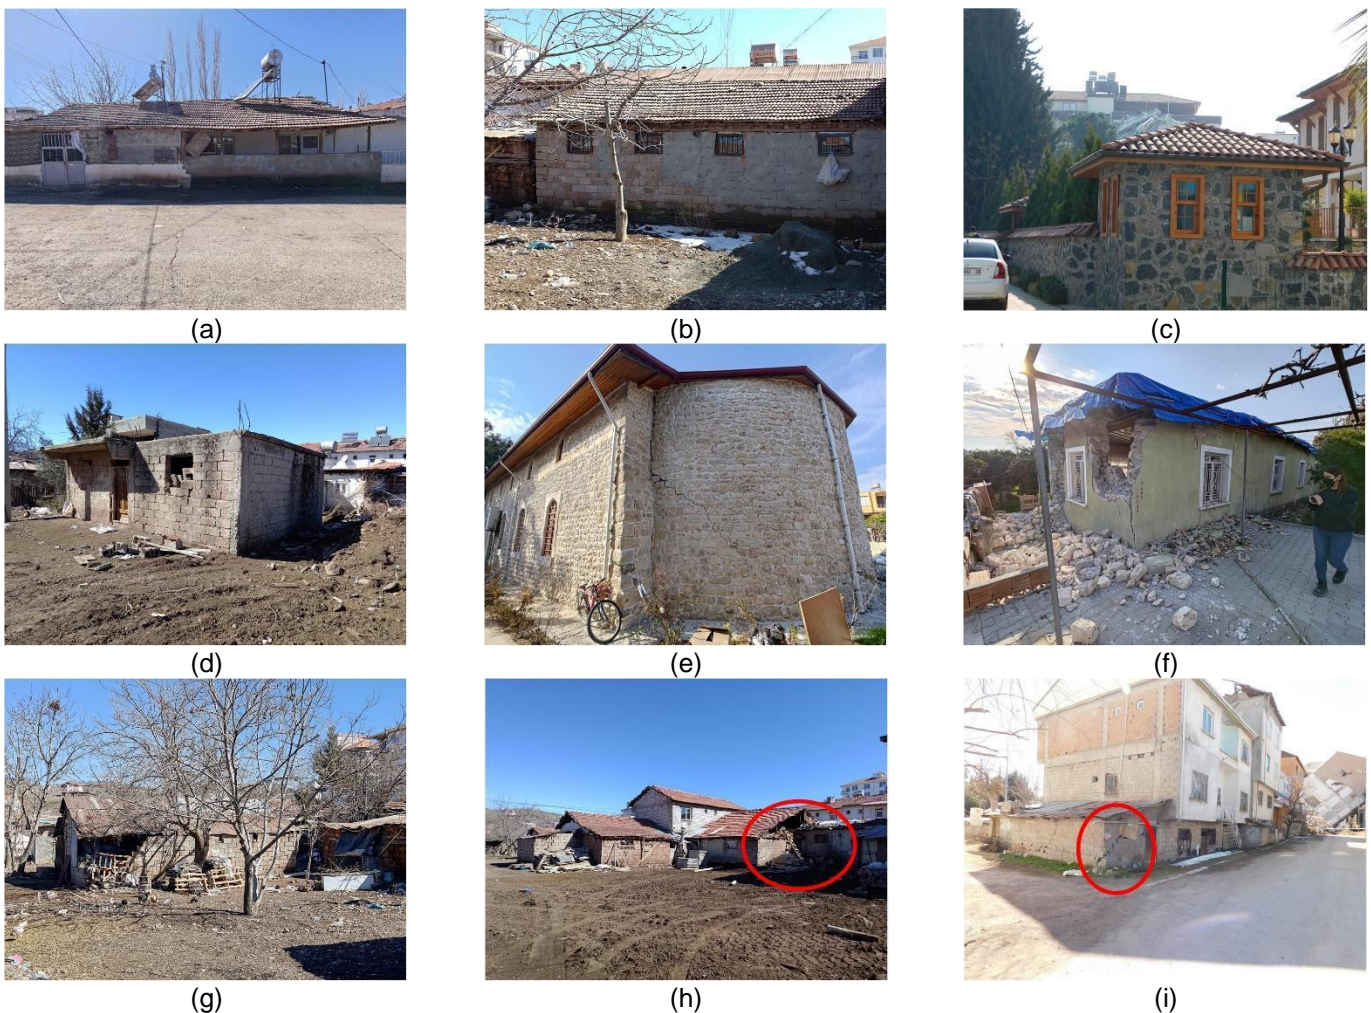
Figure 4-9 (a) to (c) essentially intact or slightly damaged masonry buildings, (d) and (e) moderately damaged masonry buildings, (f) to (h) severely damaged masonry buildings, (i) a pure sliding mode of failure mechanism of a brick wall.

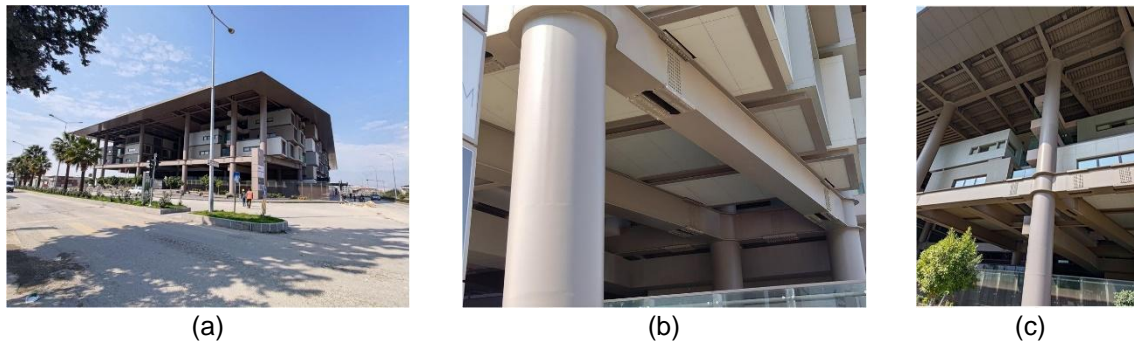
Figure 4-10 (a) A steel building, (b) splices of beam segments, (c) a beam-column joint.

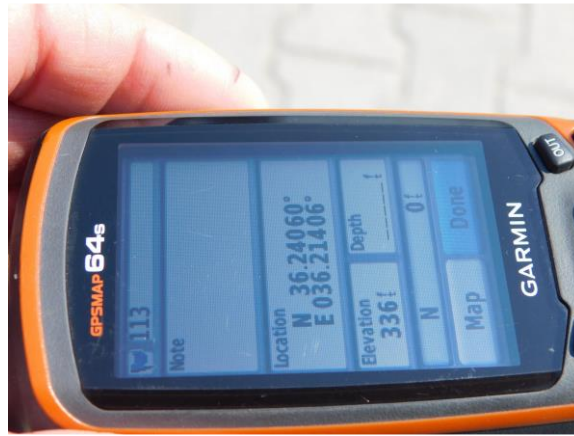
Figure 5-1 Garmin GPS Unit used in the field to determine coordinate location of bridges inspected for damage

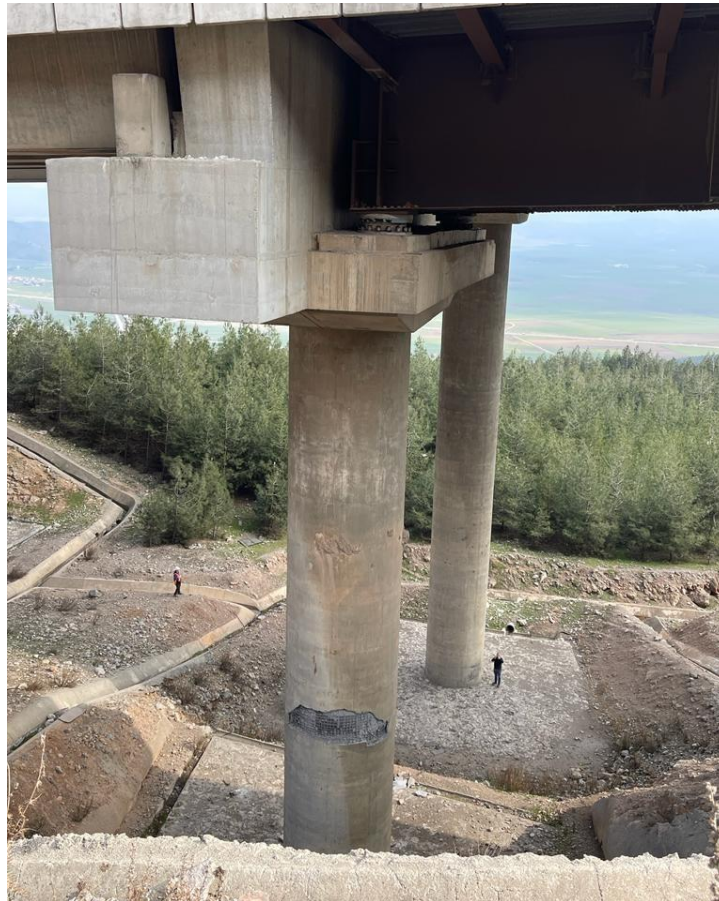
Figure 5-6 Overall view of bent with 10' diameter RC bridge columns and plastic hinge for one column at about 1/4 the way up its height, Bridge 1

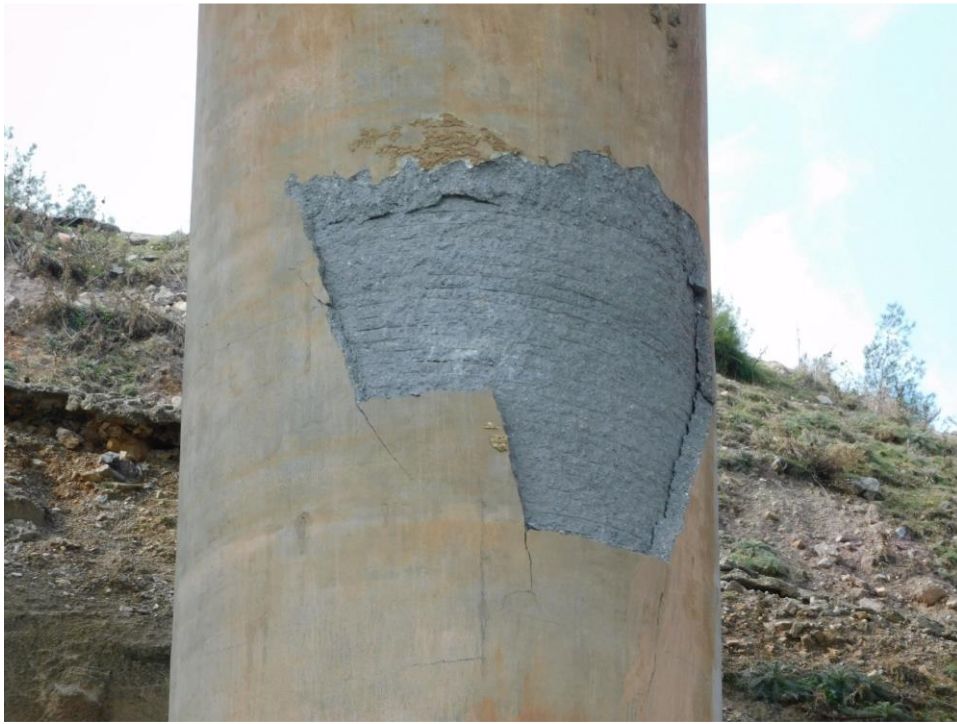
Figure 5-10 Close-up view of column plastic hinge, spalling of cover concrete (opposite side to where vertical bars had buckled), Bridge 1

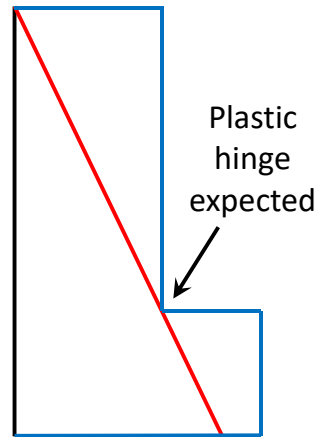
Figure 5-11 Column moment demand and moment capacity when bars are cutoff at  $\frac{1}{4}$  location of the column height, Bridge 1

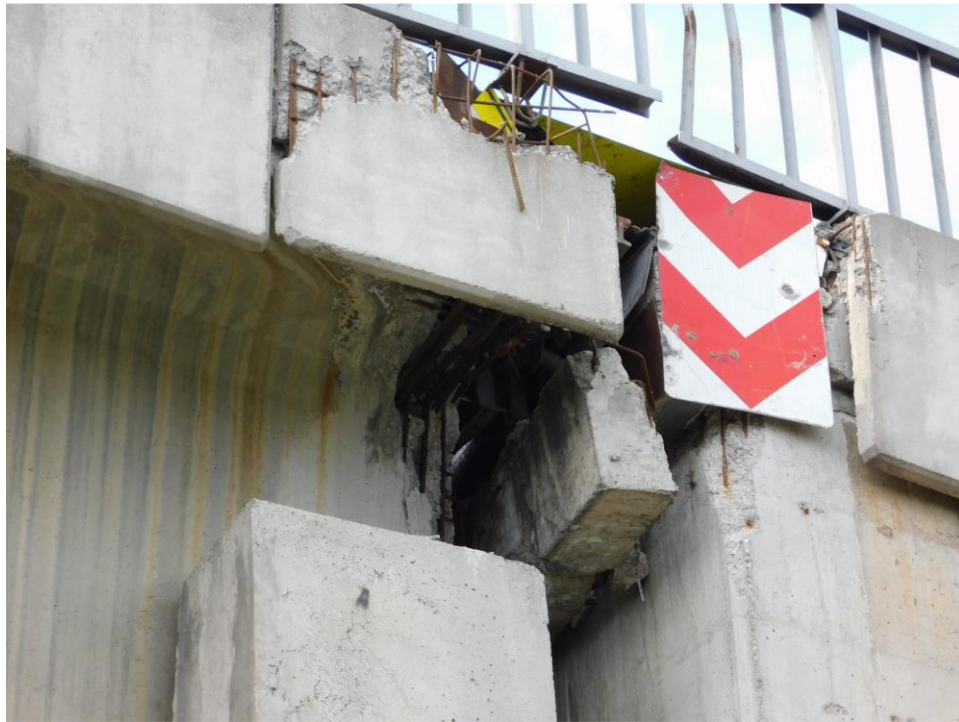
*Figure 5-12 Damage at abutment, Bridge 1*

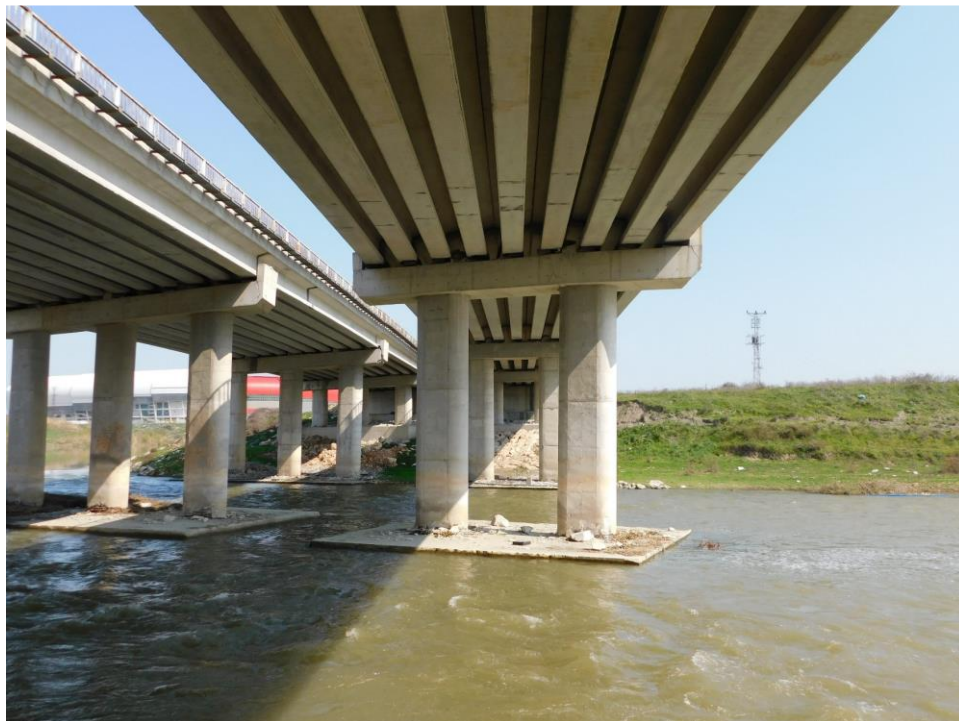
*Figure 5-13 Overall view from under Bridge 2*

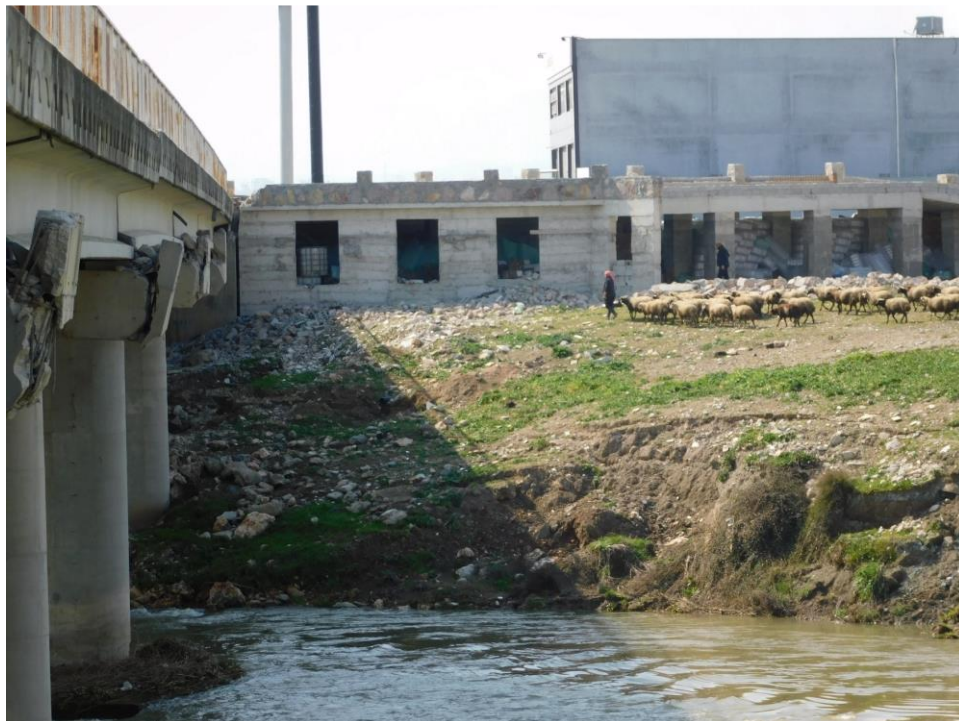
*Figure 5-16 Another view of failed exterior shear keys, Bridge 2*

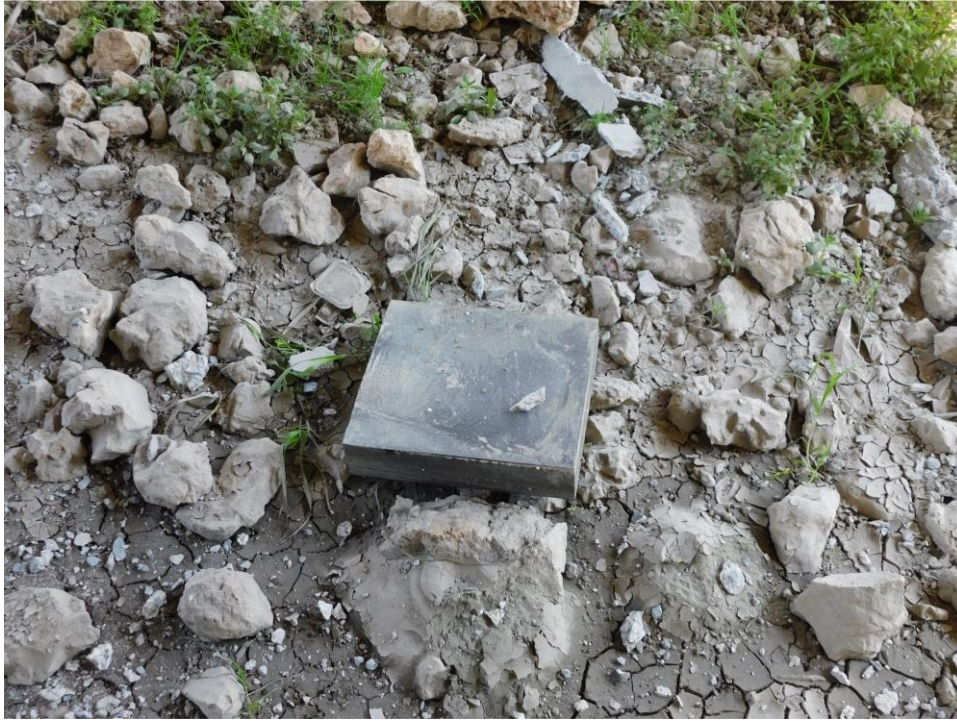
*Figure 5-17 Rubber bearing pad on ground; one of many, Bridge 2*
