## Preliminary Earthquake Reconnaissance Report: Türkiye Earthquake Sequence on February 6, 2023

### Field Assessment Team Lead

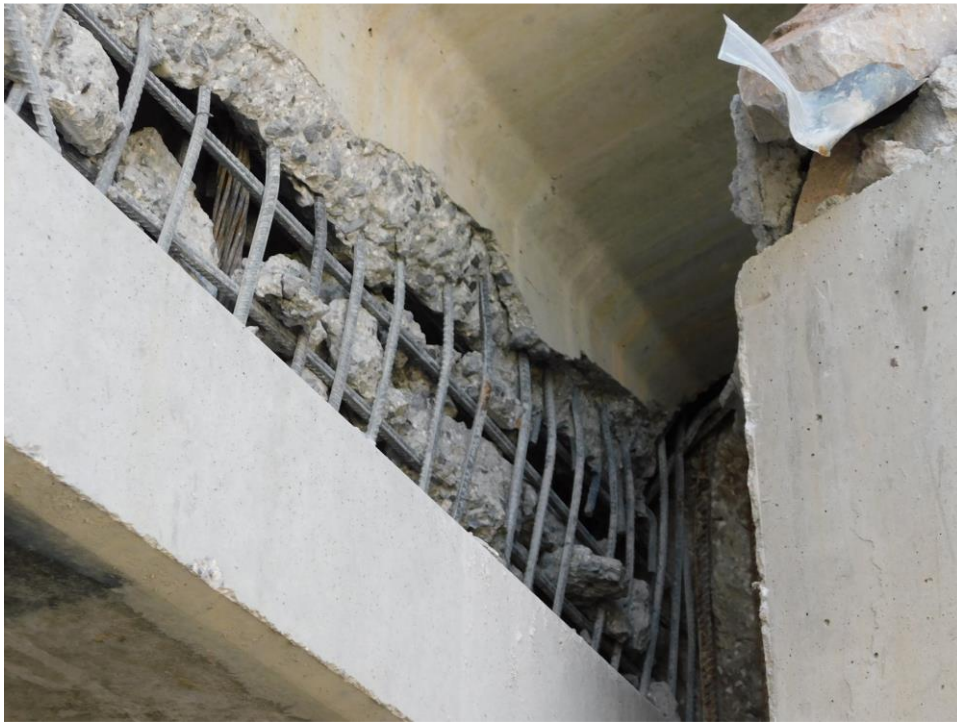
*Figure 5-19 Closer view of damage to end of precast girder, Bridge 2*

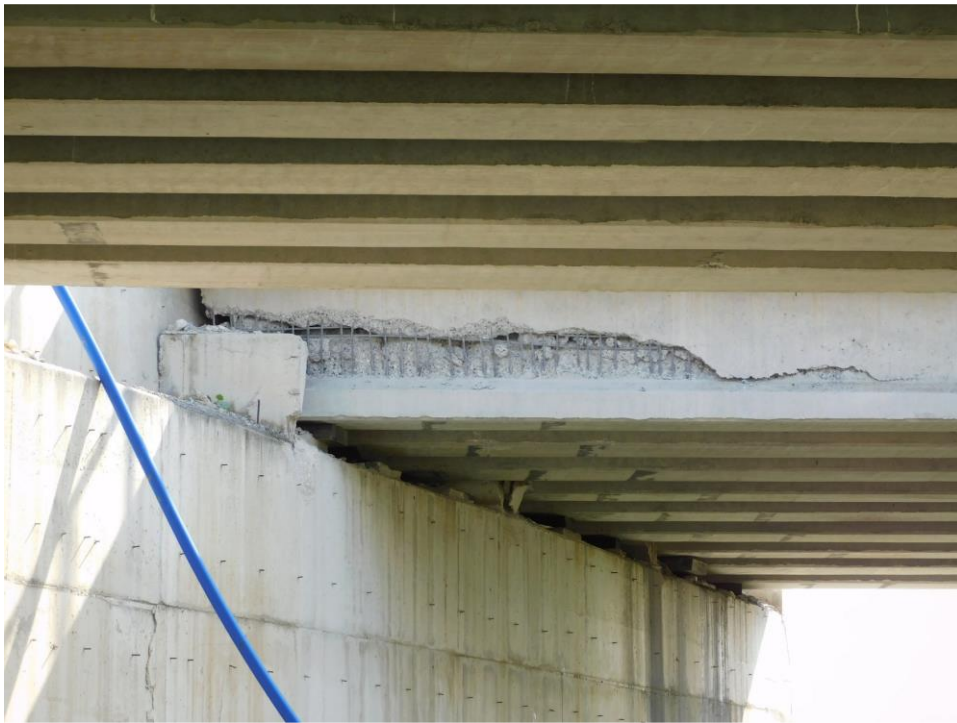
*Figure 5-20 Damage over long range to end of exterior precast girder, Bridge 2*

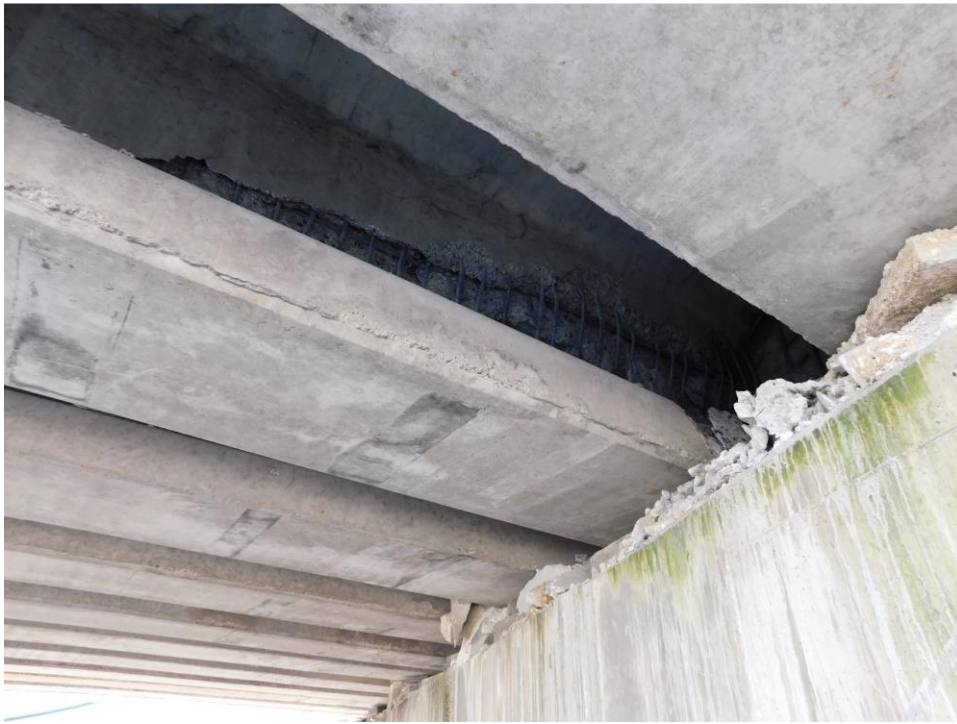
*Figure 5-23 Interior girder damage at end of precast girder, Bridge 2*

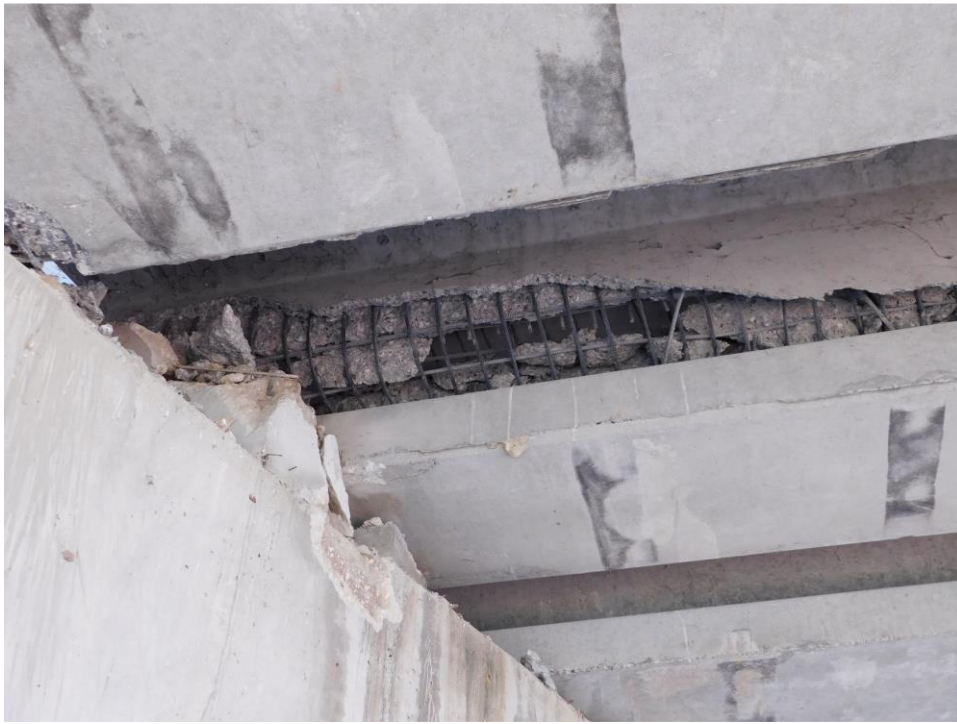
*Figure 5-25 Significant interior girder damage at end of precast girder, Bridge 2*

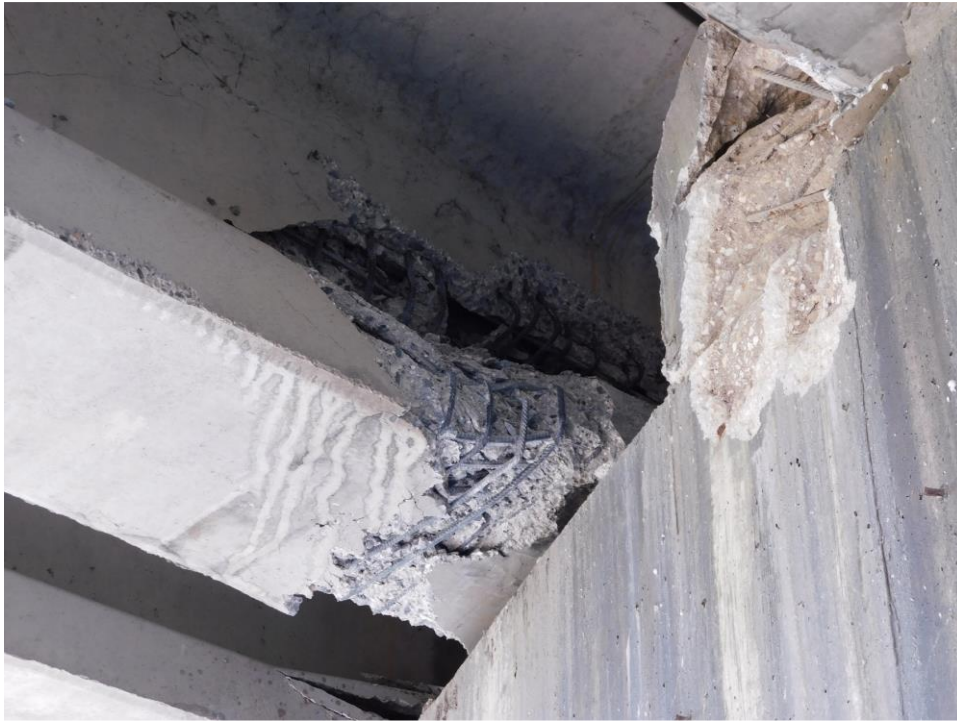
*Figure 5-26 Significant interior girder damage at end of precast girder, Bridge 2*

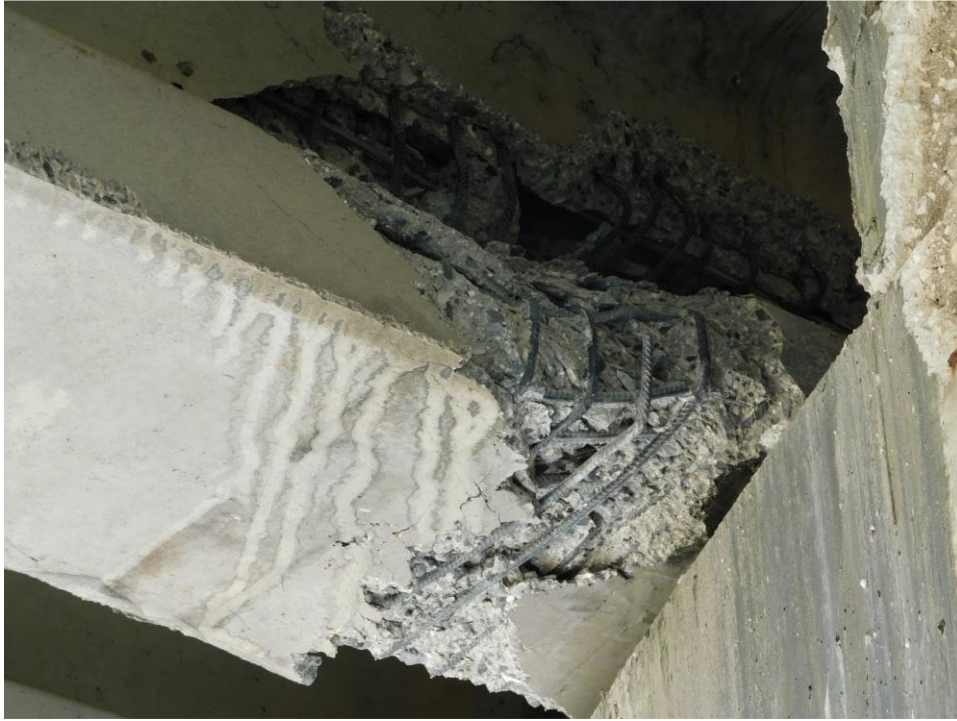
*Figure 5-27 Closer view of significant interior girder damage at end of precast girder, Bridge 2*

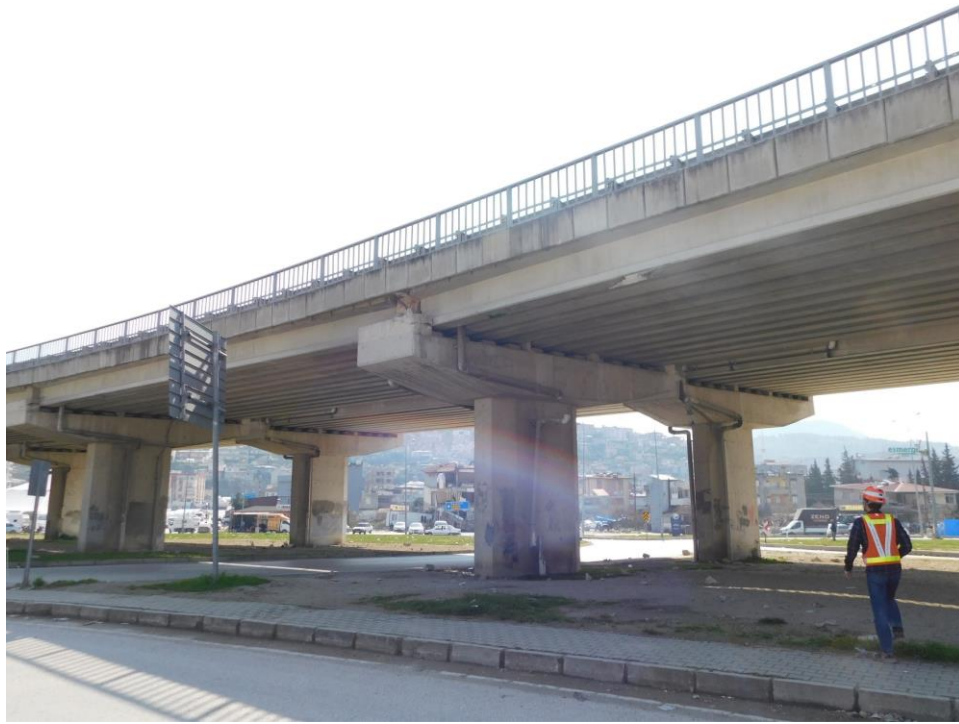
*Figure 5-32 Overall view of Bridge 3*

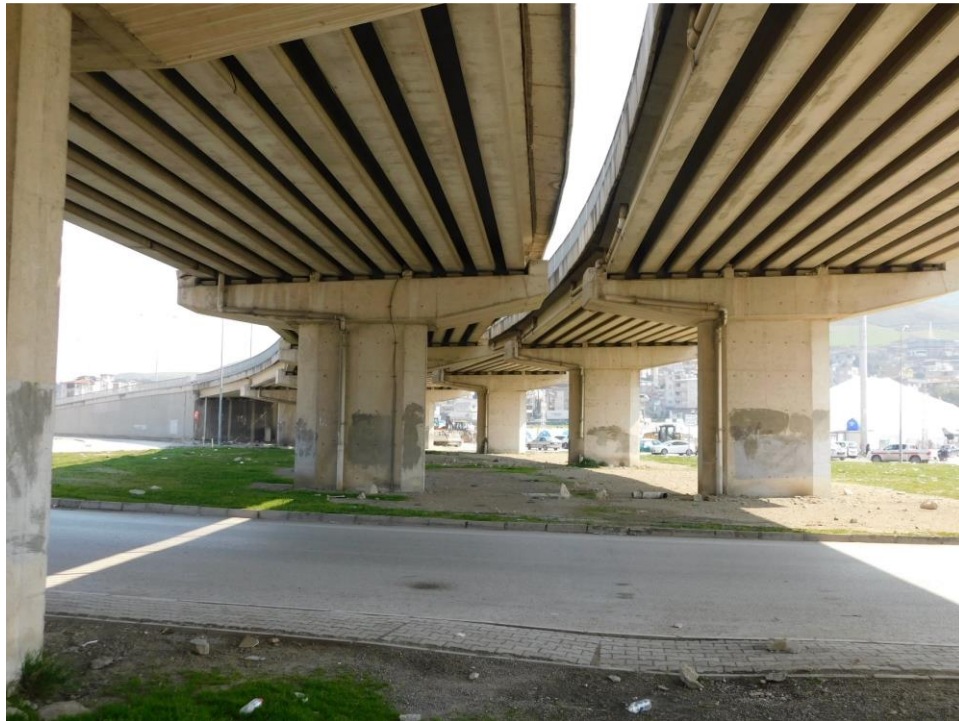
*Figure 5-33 View under Bridge 3, showing 11 precast I-girders per span for each bridge*

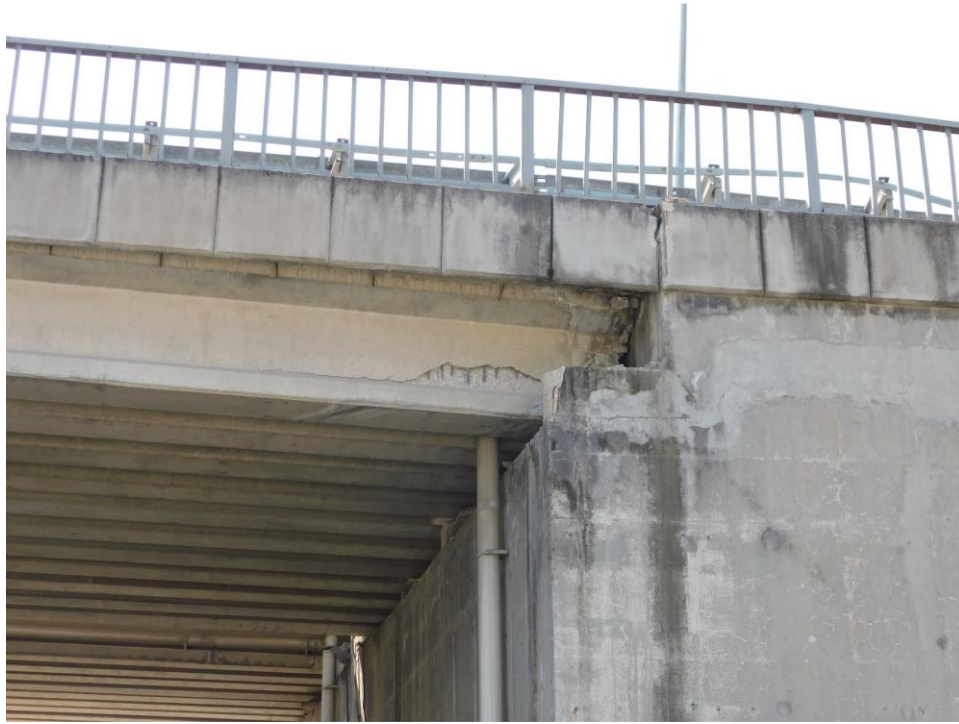
*Figure 5-34 Damage at end of Bridge 3 precast girders*

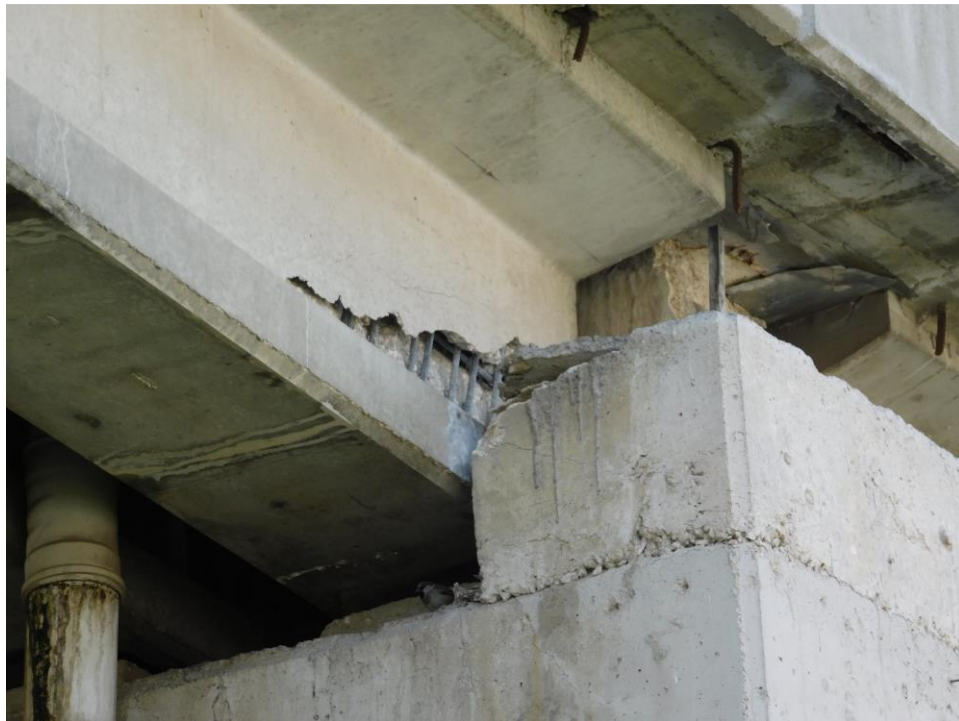
*Figure 5-35 Close-up view of damage at end of Bridge 3 precast girder*

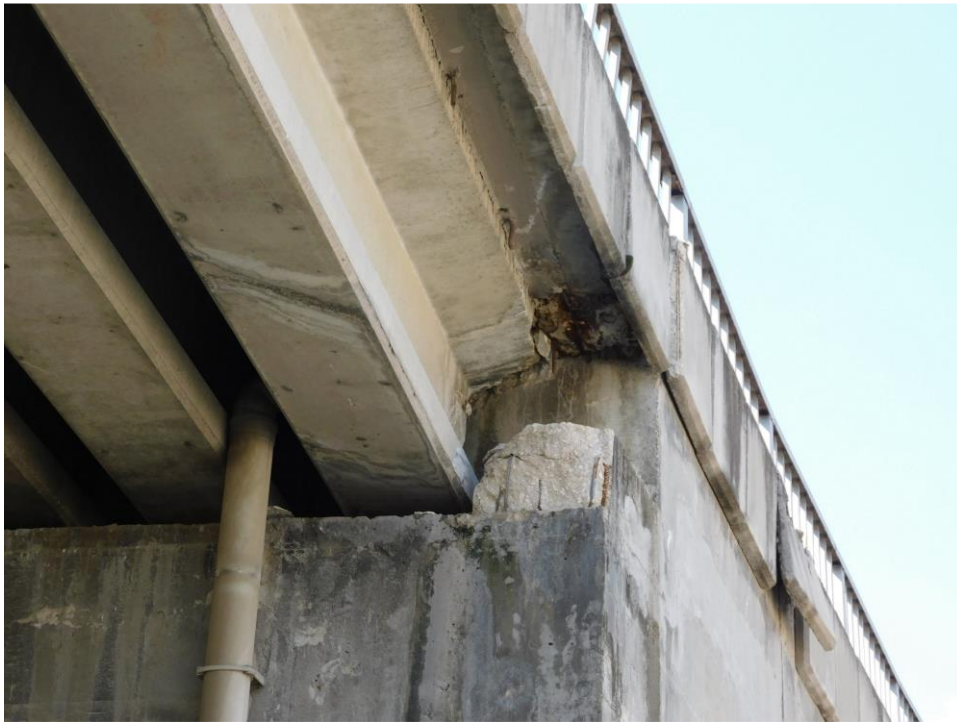
*Figure 5-36 Damage of external shear key at Bridge 3 abutment*

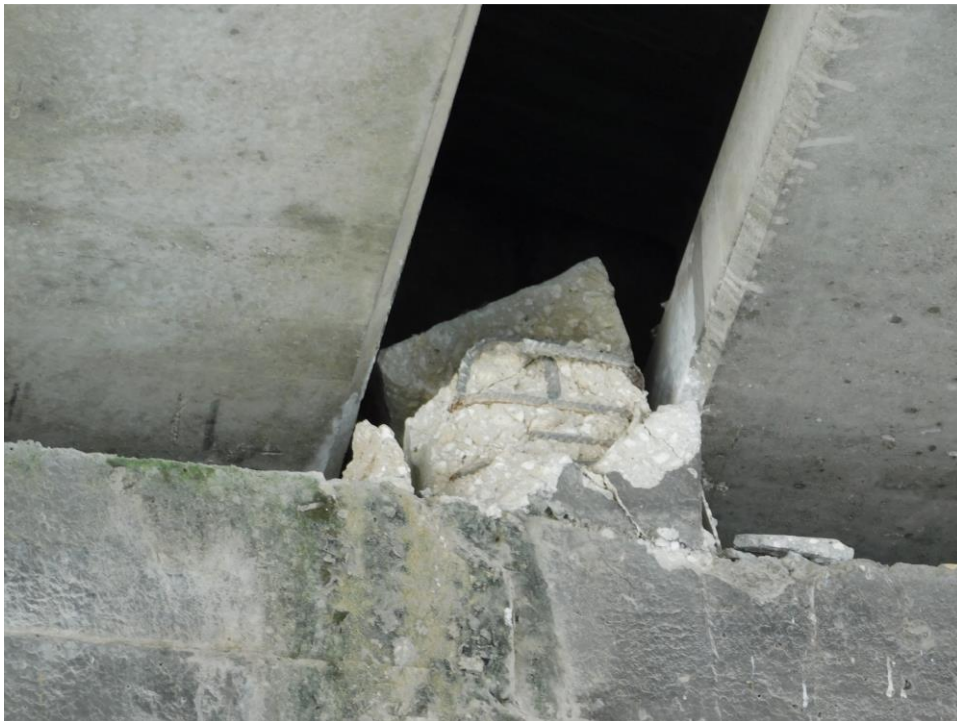
*Figure 5-37 Damage of internal shear key at bent of Bridge 3*

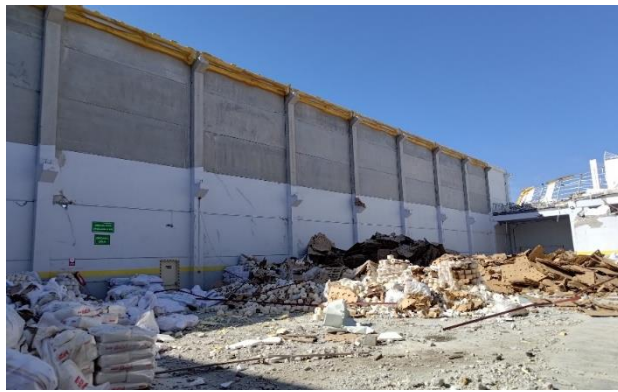
Figure 6-1 Damage of precast building (a) undamaged portion of the precast building, (b) damaged portion of the precast building, (c) corbel damage and plastic hinging of column, (d) precast slab failure

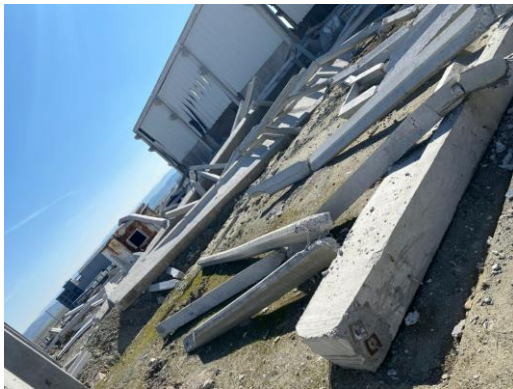
Figure 6-2 Damage of Precast buildigs in Turkoglu OIZ (a) precast tapered beam failure owing to the loss of support, (b) cladding pannels due to panel-to-structure failure

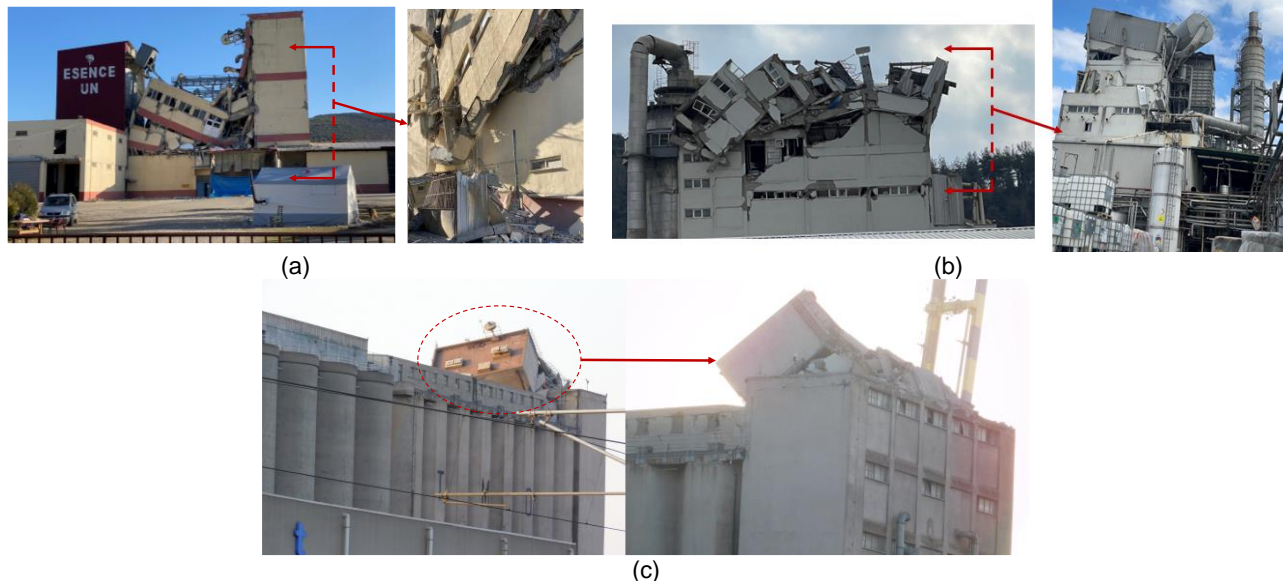
Figure 6-4 Damage of RC buildings (a) to (b) Essence Un, (c) and (d) ABC Deterjan, (e) Toprak Mahsulleri Ofisi (TMO)

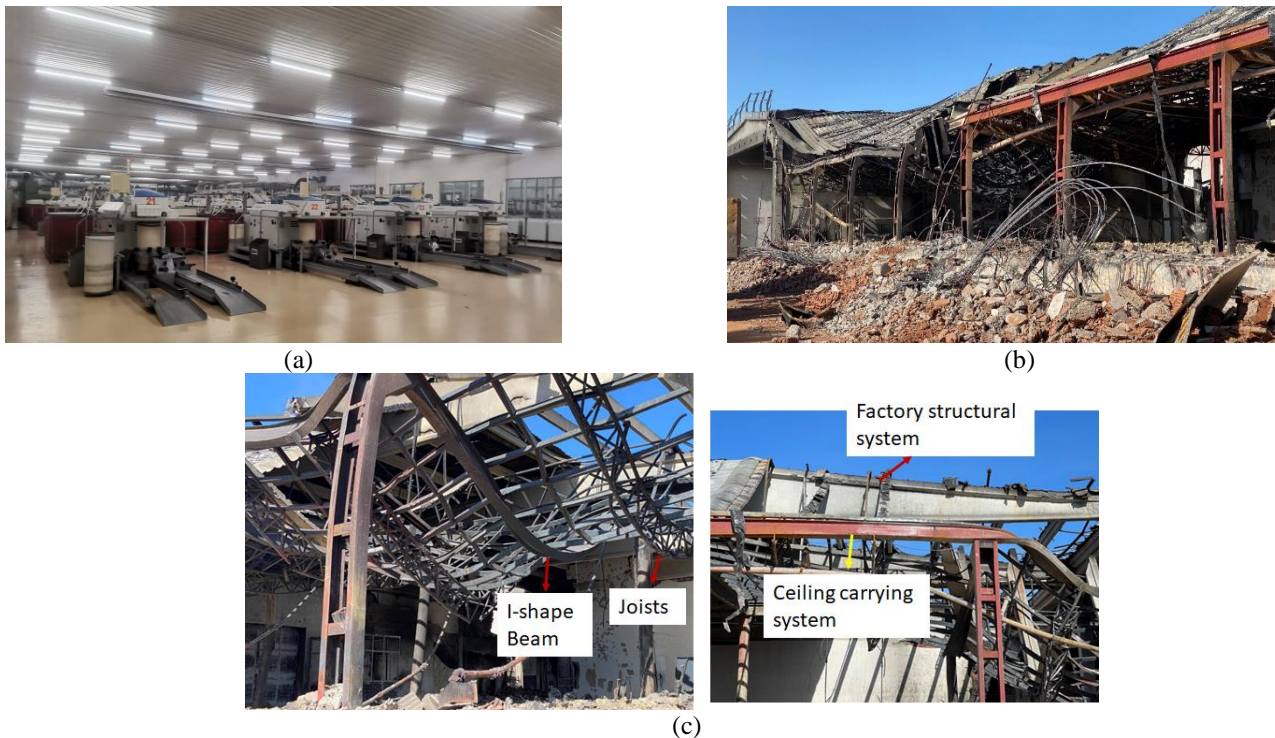
Figure 6-6 Multi hazard on steel suspended ceiling structural system (a) Prior to earthquake, (b) After the earthquake and fire, (c) Detailing

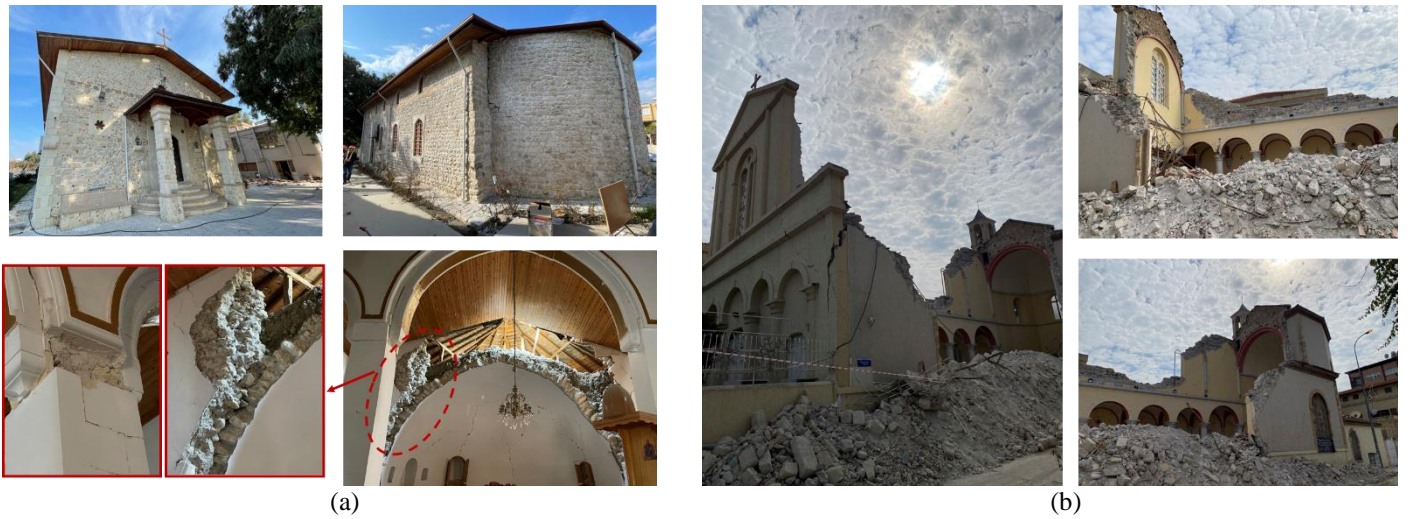
Figure 7-3 Damage of Churches (a) St. Ilyas Church in Samandagi, Antakya, (b) Roman Catholic Church in Iskenderun
