Field reconnaissance and observations from the February 6, 2023, Turkey earthquake sequence

Gulen Ozkula¹ · Robert K. Dowell² · Tugce Baser³ · Jui-Liang Lin⁴ · Ozgun A. Numanoglu⁵ · Okan Ilhan⁶ · C. Guney Olgun⁷ · Cheng-Wei Huang⁴ · Tunc Deniz Uludag⁸

Received: 20 March 2023 / Accepted: 11 August 2023 / Published online: 28 August 2023
© The Author(s), under exclusive licence to Springer Nature B.V. 2023

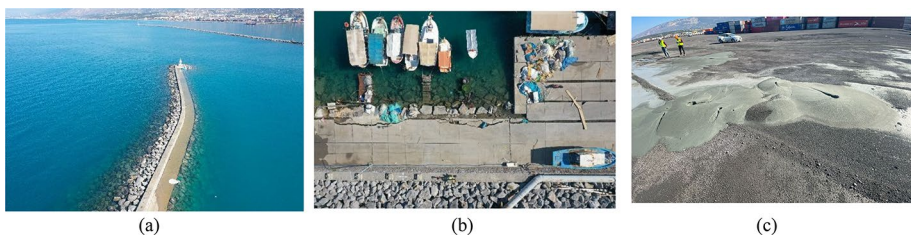
Fig. 8 Ground settlements and lateral deformations on Iskenderun dock (~36°35'40.67"N/36° 10'38.69"E): **a** ground subsidence at the pier and the lighthouse; **b** ground subsidence at the dock; **c** free field sand boils at the port

observed to be between 5 and 30 cm under the multi-story building, whereas settlements at the public dock reached values as high as 150 cm (Fig. 8).

buildings on shallow foundations. It is estimated that the waterfront area settled by about 50–60 cm and the buildings on mat foundations in this area settled by about 5–50 cm. Ground subsidence as high as 150 cm was observed at the Iskenderun dock situated at the northern end of Iskenderun. It was also observed that the severity and magnitude of liquefaction-related ground failure gradually diminished by about 400–500 m inland from the waterfront. This transition can be attributed to the decreasing thickness of the liquefiable deposits inland from the waterfront. It was observed that buildings and structures founded on deep foundations with jet grout columns performed well, without any catastrophic failure.

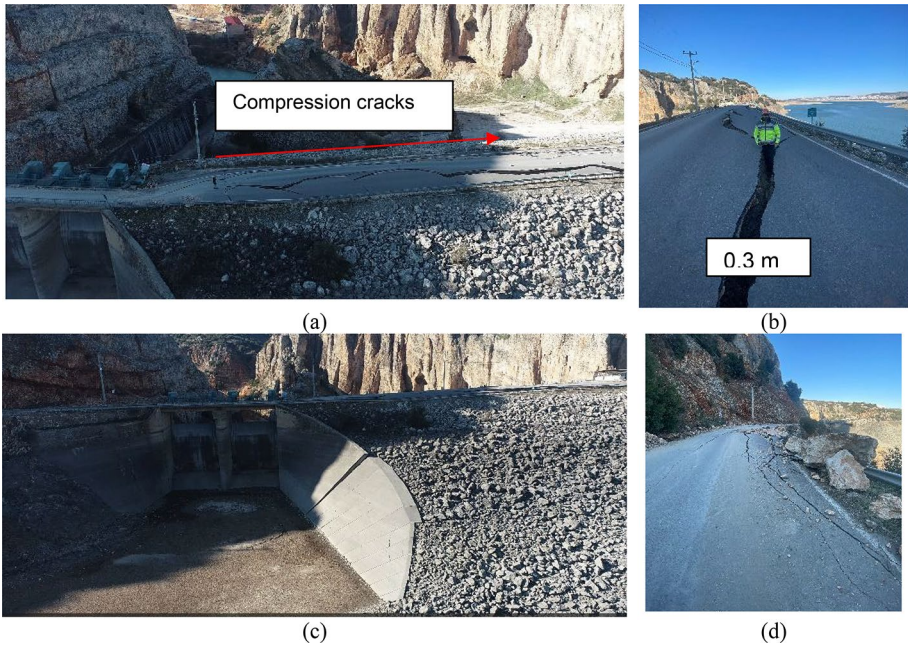
Several earthquake-induced damages were observed at the Kartalkaya Dam in Kahramanmaraş and the Ariklikas Dam in Osmaniye. The Kartalkaya is one of the most important dams in the region, as it has been supplying irrigation water to Pazarcik County and tap water to the city of Gaziantep. The dam was built on the Aksu River for irrigation and for flood prevention for the town of Pazarcik. The Kartalkaya Dam has a crest elevation of 720 m and catchment elevation ranging between 680 and 2470 m. It has been in operation since 1971 with a reservoir area of 11 km² and a drainage area of 1088 km² that can supply irrigation water to 200,000 acres of farmland. During the construction phase, the capacity was calculated as 200,000,000 m³, but current capacity has decreased to 160,000,000 m³ because of the sediment fill in the reservoir. The sediment fill caused by rainfall-induced erosion has led to several studies focusing on erosion in the area (Yuksel et al. 2008; Taskesen Ozturk, 2018). Significant damages on the crest and right-wing of the Kartalkaya Dam are shown in Fig. 9, which are associated with the combined effect of seismic load-induced cracks and lateral displacements at the central part of the crest, and rockfalls of the upstream part of the dam. The cracks are longitudinal to the dam crest, with dimensions of twenty meters long and having a depth of 0.5 m and width of 0.3 m. No significant orthogonal cracks were observed in the crest. There was no upstream or downstream damage observed at the side slopes. The reservoir had already been almost empty due to the present climate, and there was no leakage through the gates. Wings located at the water inlet through the gates have damage due to intense shaking. One segment moved toward the earth dam, where seismic compression occurred. Besides there are no connections between segments on the wings so that damaged segments easily move apart.

Fig. 9 Deformations observed on the Kartalkaya dam (~37°28′06.01″N/37°14′20.14″E): **a** compression cracks and lateral displacements at the crest of Kartalkaya dam; **b** longitudinal cracks in the middle of the crest; **c** moved segment and compression; **d** earthquake-induced rock fall and associated cracks on the crest

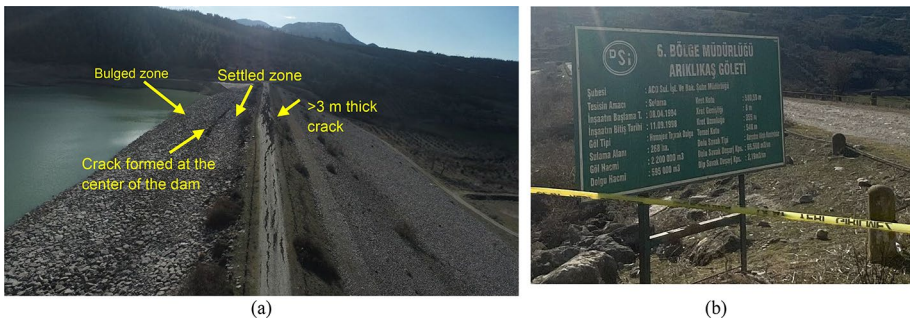
The Ariklikas Dam is a homogeneous earth dam constructed between 1994 and 1998 in Osmaniye for irrigation purposes. The crest height from the stream level is almost 32 m. Cracks formed during the earthquakes at the crest level, with crack widths ranging from 2.2 m to 4.0 m. The lateral movement is toward the upstream. No damage was observed on hydraulic structures, except for minor cracks on the curtain walls of the spillway. In addition, the face of the dam at the upstream side was observed to be significantly settled close to the crest and bulged out towards the toe of the dam, with a visible opening at the center of the slope. The details of the slope instability and information of the dam are given in Fig. 10a, b, respectively.

Fig. 10 Deformations observed on the Ariklikas (~37°09′25.70″N/36°30′55.96″E) dams: **a** Ariklikas Dam (side view); **b** Ariklikas dam construction details (in Turkish)

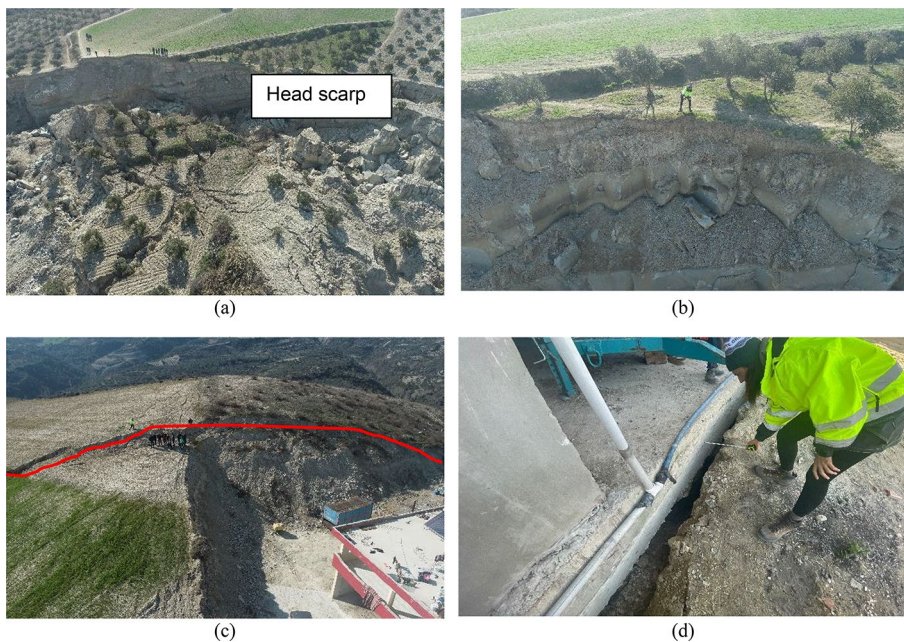
Fig. 12 Landslide at an olive farm near Turkey-Syria border (Altinozu, Hatay): **a** main crack (bird's-eye view) at $\sim 36^{\circ}09'42.41''\text{N}/36^{\circ}13'13.40''\text{E}$; **b** main crack—near-front view of the crack; **c** potential landslide origin and tension cracks at $36^{\circ}09'28.18''\text{N}/36^{\circ}13'00.65''\text{E}$ **d** displaced single family home in Tepehan village

The slope of the landslide ranges from 15 to 25 degrees, steepening towards the toe. The area had been particularly dry for several years, and there is a potential for causing extensive desiccation cracks. There was a heavy rainfall that lasted for several days preceding the earthquakes, inundating and saturating the dry soil through the cracks.

The massive landslide followed the earthquakes, triggering a mass movement of several cubic meters of soil and rock debris. This landslide might further mobilize due to rain-falls and creep. The team found the potential origin of the landslide, which was manifested with tension cracks approximately 300 m above the head scarp (Fig. 12c, d).

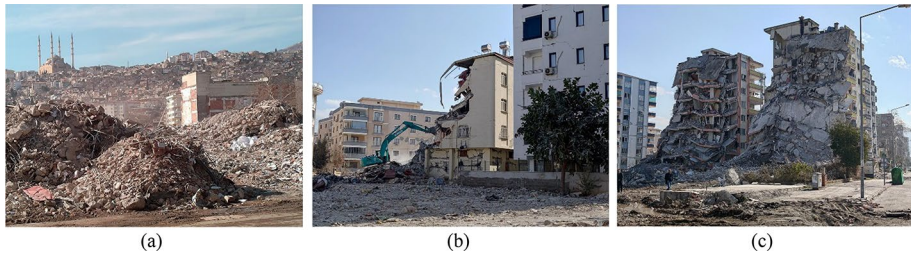
Fig. 15 **a** Demolition work, **b** an excavator pulling down damaged buildings, **c** the damage states of buildings possibly contaminated by demolition work

The structural reconnaissance team visited the region affected by the earthquake sequence on February 20, i.e., two weeks after the earthquakes. It was observed that demolition work had started before the reconnaissance (Fig. 15a), i.e., some heavy machines, such as excavators with buckets or claws, had pulled down some damaged buildings, as shown in Fig. 15b. An effort was made to exclude the damage states of buildings that were possibly exacerbated by demolition work (Fig. 15c) as noted by discussion with local authorities. Overall, the observations were in agreement with reported condition assessments conducted by the Ministry of Environment and Urbanization of Turkey (MEUT) on 736,851 buildings in the effected region. Collected data show that a total of 19,284 buildings collapsed from the earthquake sequence and almost half of the investigated buildings (373,038) were damaged to varying levels as shown in Table 1.

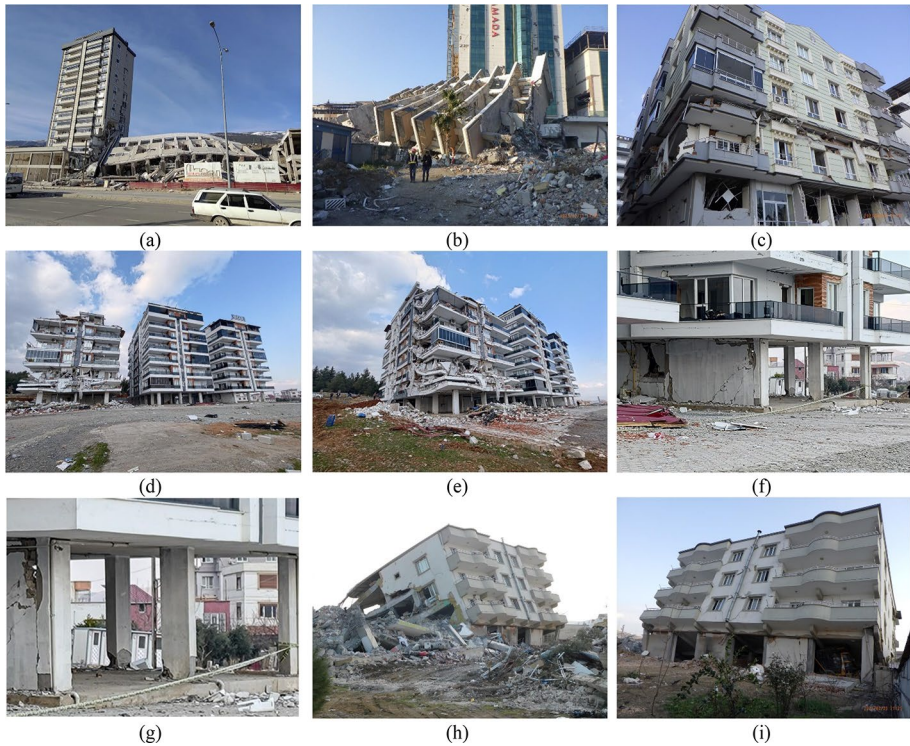
Fig. 17 **a** and **b** lie-down collapsed buildings, **c** a building with pancaked third story, **d** and **e** three similar buildings with different damage states, **f** close-up photograph of the first story of the right building, **g** bi-directional and one-directional plastic hinges, **h** and **i** a knee-down collapsed building

was occupied, as shown in Fig. 17b. If the lateral force-resisting system of the building shown in Fig. 17a had been completed before the earthquake, the soft-and-weak lower story of the building could be attributed to either design or construction issues, rather than the possibility of the building being remodeled by occupants. Figure 17c shows a sit-down collapsed six-story building with a pancaked third story, which is also called a soft story. Figure 17d shows three similar eight-story buildings with different damage levels. The left building partially pancaked at the second, third, and top stories (Fig. 17e), but the other two buildings were only moderately damaged. This observation implies that the lateral force-resisting elements on the front side of the second and/or third stories of the left building probably had been remodeled before the earthquake, which resulted in the weak second and/or third stories.

The far-right building in Fig. 17d has a masonry wall at the first story so its damage was less than that observed in the mid building. The wall showed shear failure with two major diagonal cracks at angles of 45° and 60° (Fig. 17f). Additionally, bi-directional and one-directional plastic hinges were successfully formed at the bottom ends of the first story columns (Fig. 17g). The bi-directional plastic hinge indicates that the building suffered significant ground motion in both mutually perpendicular horizontal directions. Because strength deterioration of a column in one direction affects the performance of the column in the other direction, three-dimensional analysis and design of buildings should be

stressed in the future. Figure 17h, i shows a knee-down collapsed building, in which the beams were separated from the columns and walls. By observing the almost intact surface of the beam bottom, it indicates that the beams were inadequately connected not only with the walls, but also with the columns. Furthermore, by observing the relatively separated locations between the beams and columns of the first story, this building was likely displaced rightward and inward of the photograph. That is to say, the building experienced rotational displacement demands in plan view (twisting) under the earthquake. Some buildings collapsed or were damaged by issues (e.g., soil liquefaction) other than structural. Figure 18a, b illustrates an overturned building and unequal settlement of a building, both with good structural integrity. Figure 18c, d shows ground settlement, surface cracking, and sand boils, which indicate soil liquefaction in that area. Secondary disaster caused by the earthquake was also noticed; Fig. 18e shows a building, in which damage caused by fire is perhaps more serious than that caused by the earthquake shaking. Figure 18f indicates a slightly-to-moderately damaged five-story building with some damaged facilities (e.g., water tanks) at top the roof. Although the building was successful against the seismic strike, damage of nonstructural components certainly affected the function of the building.

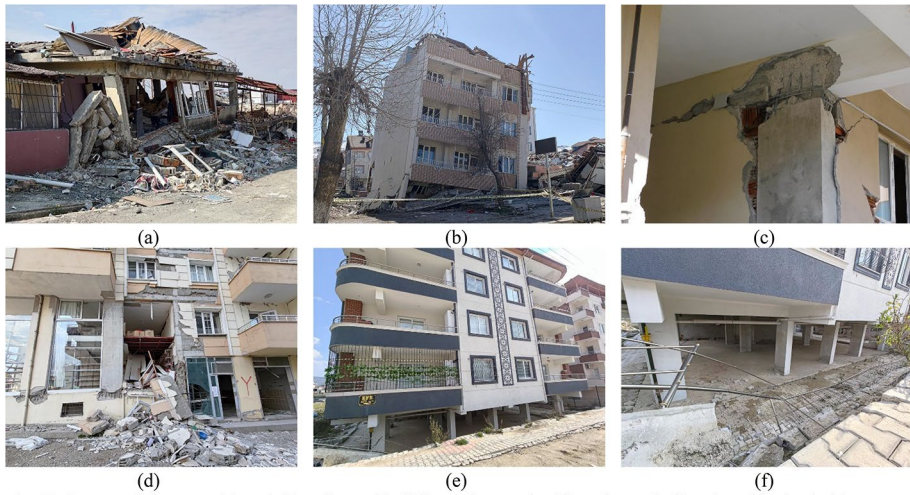
Figure 19a and b shows that two buildings collapsed along the street because the weak direction of columns was oriented along the street. The large aspect ratio of column cross sections, rather than a square, seems to be common in the region that was observed to increase indoor space. Nevertheless, once all columns are oriented in the same way, the building would be soft and weak in the weak-axis direction of the column, i.e., the vulnerable direction of the building to earthquakes. In addition, the strong beam-weak column concept likely exists in the weak direction [i.e., plastic hinges will be formed in columns rather than in the beams, such as that shown in Fig. 19c]. Figure 19d shows the

Fig. 19 Structural damages **a** and **b** collapsed buildings along a significantly weak direction; **c** plastic hinges at top and **d** plastic hinges at bottom of columns, **e** an almost intact building, and **f** a close-up photograph of **e**

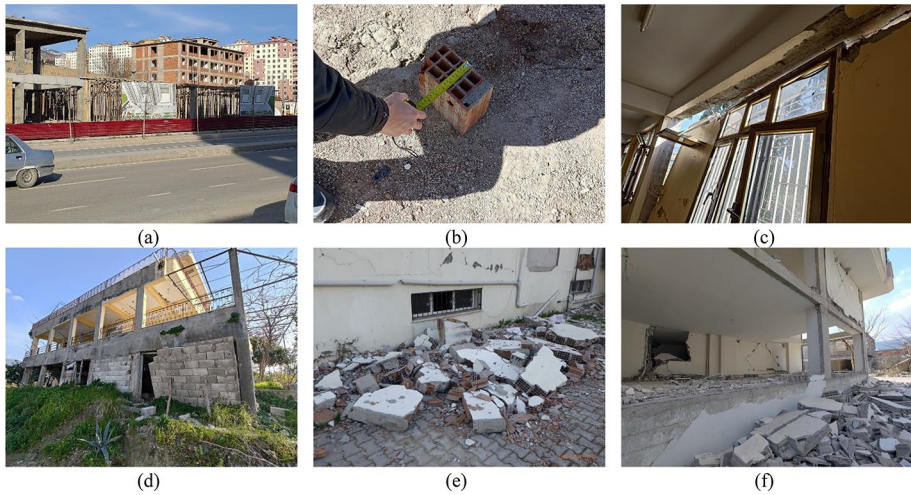
Figure 20a shows two buildings at one construction project. The progress of the right building was ahead of that of the left building. Figure 20a shows that the exterior and partition walls (often called infill walls) are usually made of bricks, which are erected after completing the beam-column frame system. The thickness of typical brick walls is 15 cm, which consists of 10 cm thickness of bricks and 2.5 cm covering on both sides of the bricks (Fig. 20b). Because there are no connectors between the brick walls and beams/columns, the brick walls fall out of the beam-column frames (Fig. 20c–e). At this point, it is not clear if the infill walls are considered in the structural analysis and design of the buildings in Turkey. Nevertheless, Fig. 20f shows that the infill walls indeed share the seismic force and partially support the building weight. Beams and columns were thus protected from damage to a certain extent (Fig. 20f). However, the participation of infill walls in the lateral force resistance significantly increases the lateral stiffness of beam-column frames. Therefore, the actual vibration periods of buildings with infill walls are substantially less than those obtained from numerical models without considering infill walls. In other words, the actual sustained seismic force of buildings is probably greater than the design base shear obtained from the numerical models without considering infill walls. Also infill walls falling to the streets represent a severe hazard to people. Turkey should decide to either consider infill walls in the seismic performance or not. These walls should be connected properly to the RC frame members and bricks or blocks properly connected to each other. If the

Fig. 20 **a** Two buildings of one construction project, **b** a typical brick, **c** and **d** brick walls popped out of frames, **e** brick walls fallen down, **f** beams and columns were almost intact but brick walls seriously cracked

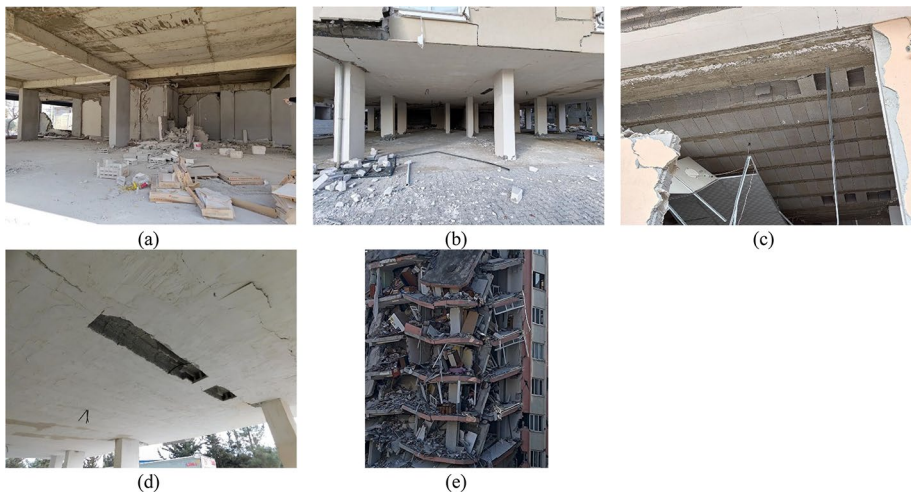
The floor slab systems used in Turkey seem to be categorized into two types: one type is supported by beams and columns (Fig. 21a) and the other type is supported by only columns which can be called hidden beam slabs [i.e., no beams, as shown in Fig. 21b]. The hidden beam slab usually consists of a flat slab that is reinforced with steel bars and has a shallow beam integrated into it. The beam is usually placed at the perimeter of the slab and

Fig. 21 A floor slab system **a** supported by beams and columns, **b** directly supported by columns, **c** and **d** bricks of the no-beam slab system fallen down, **e** a building with the no-beam slab system was under demolition

is surrounded by the concrete slab. The beam and slab work together to transfer loads from the structure above to the supporting columns or walls. However, it was observed that these slabs are made of bricks, whereas the bricks are possibly fallen down from earthquakes, as shown in Fig. 21c, d. In light of some collapsed or seriously damaged buildings consisting of that floor slab system [e.g., Figs. 17b and 21e, which is a close-up photograph of the left building shown in Fig. 15c], the seismic performance of the no-beam slab system is certainly in doubt.

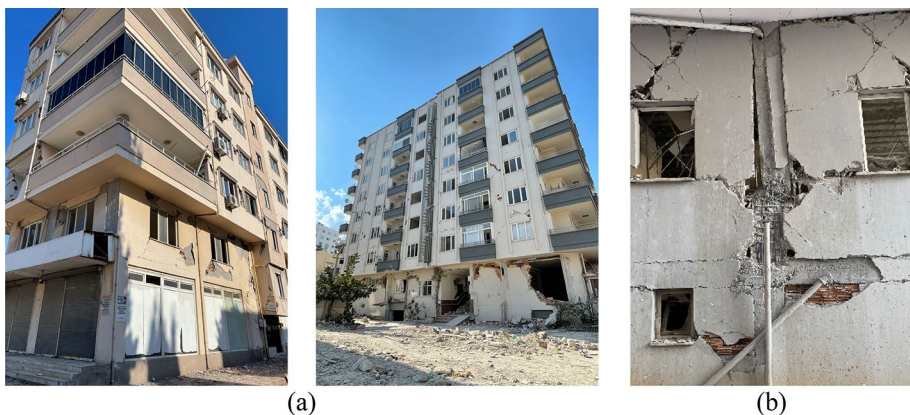
In Turkey, close and open overhangs are commonly used in building design, such as balconies, semi-balconies, and extended rooms. However, previous earthquakes have shown that buildings with overhangs tend to sustain more damage compared to those without. Despite that the Turkish seismic design code allows for overhangs and requires them to be designed to withstand seismic loads, numerous issues have been reported during construction in post-earthquake assessments (GEER 2020, DAUM 2020, METU-EERC, 2011). Damage examples caused by overhanging structures are shown in Fig. 22a. High stress is placed on the columns at cantilever beam connections that intersect with overhangs, leading to significant structural damage at these critical locations. To increase rigidity at these junctions, it may be advisable to use reinforced concrete walls instead of columns if overhangs are unavoidable. A common type of column damage occurs when the columns are partially restricted from lateral movement by strong infill walls or nonstructural partitions of partial heights. These captive columns are prevalent in many buildings, often found in areas such as staircases, toilets, and rooms with windows, primarily because structural engineers do not typically consider them in their earthquake-resistant designs. As shown in Fig. 22b, these captive columns can sustain significant damage during earthquakes. Additionally, it has been demonstrated that equations provided in the main design codes, such as ACI 318 (2005), cannot accurately predict their shear capacity, with the difference sometimes exceeding 150%. Consequently, their existence in buildings should be avoided.

Fig. 22 Residential building damages **a** due to overhangs, **b** captive/short column due to strong infill walls

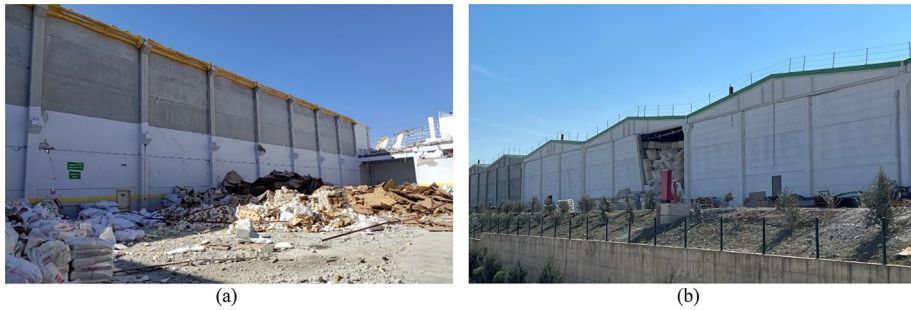
Fig. 30 Damage of precast buildings in Turkoglu OIZ **a** precast tapered beam failure owing to the loss of support, **b** cladding panels due to panel-to-structure failure

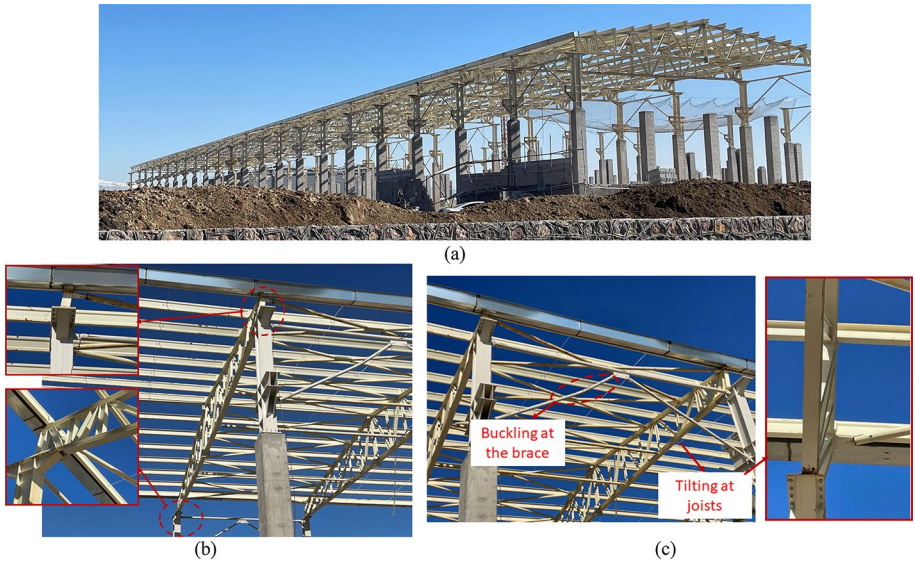
Fig. 32 Damage of steel roof system including reinforced concrete columns **a** overall view of structure, **b** steel truss tilting, **c** buckling at the brace due to collapsing of light roof covers

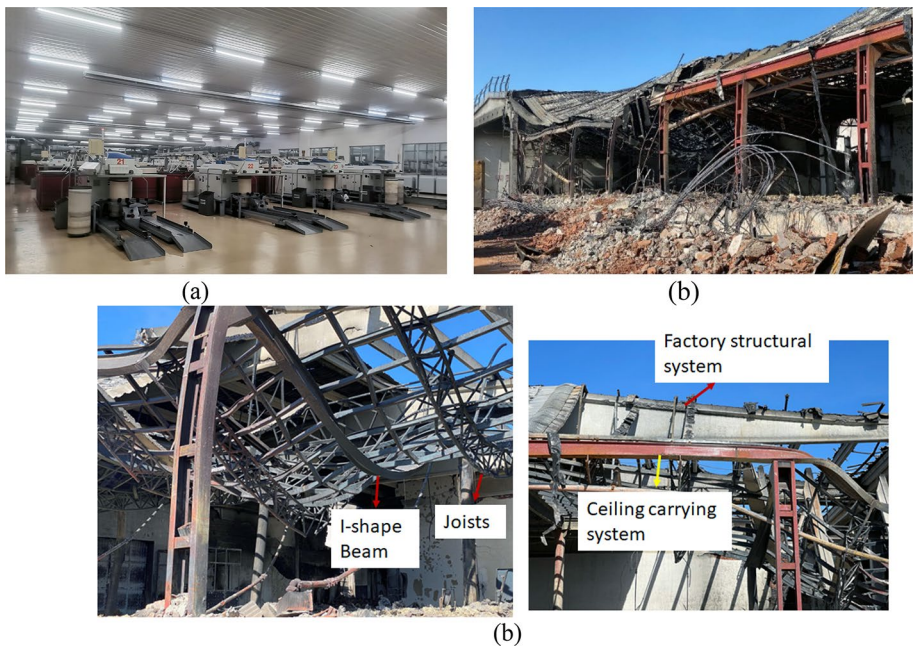
Fig. 33 Multi-hazard on steel suspended ceiling structural system **a** prior to earthquake, **b** after the earthquake and fire, **c** detailing

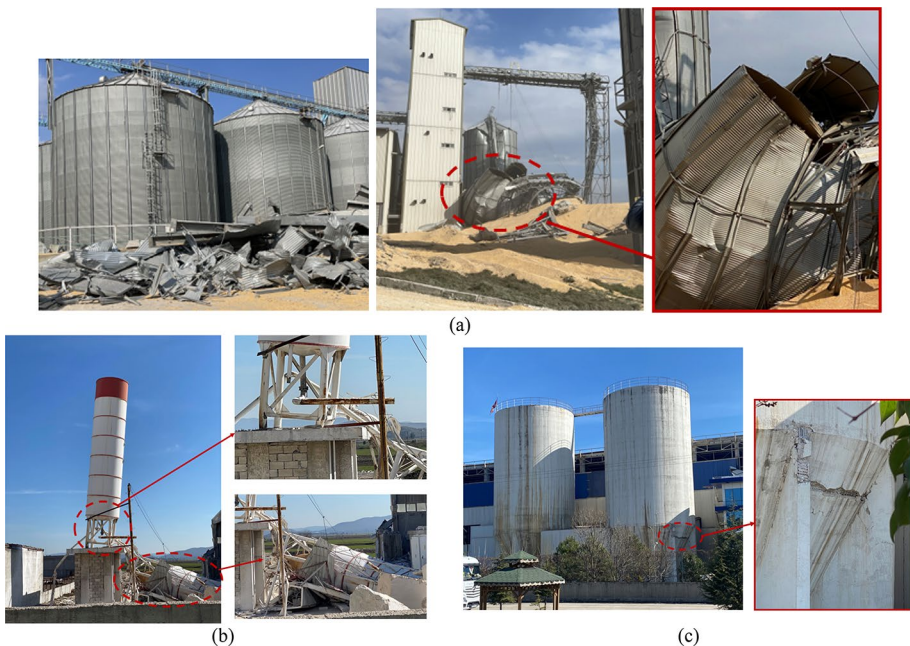
Fig. 34 Damage of silos **a** corn silos, **b** total collapse of a slender metal silo due to brittle welded connection, **c** concrete spalling on silos

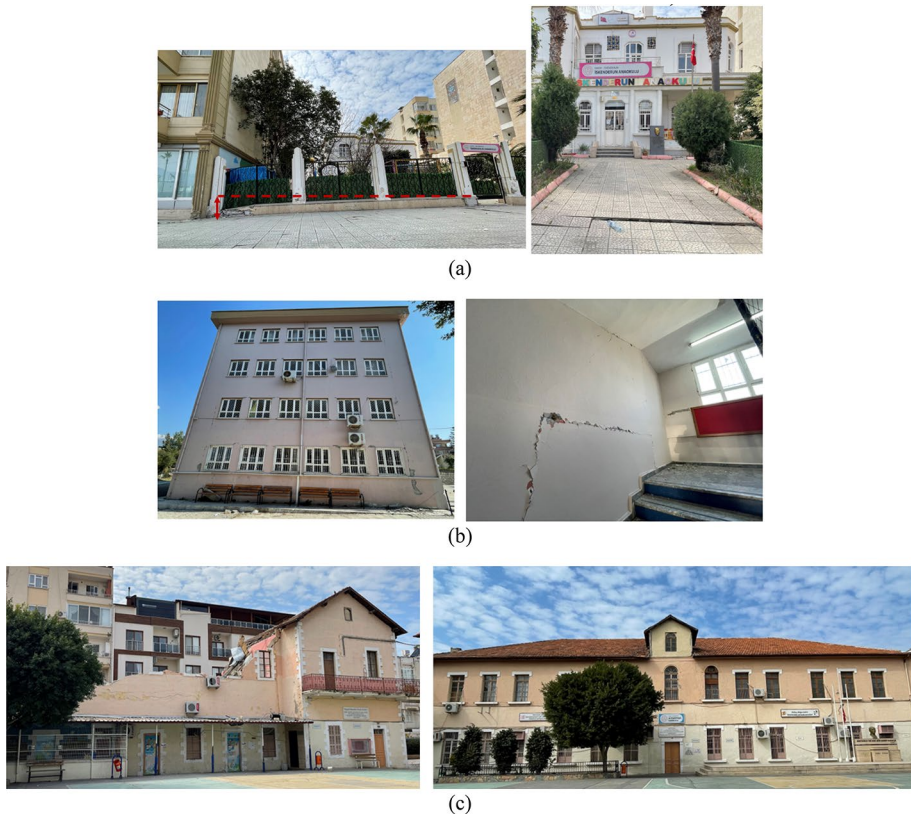
Fig. 35 Performance of schools in Iskenderun **a** Pre-school, **b** Retrofitted elementary school, **c** Unretrofitted elementary school

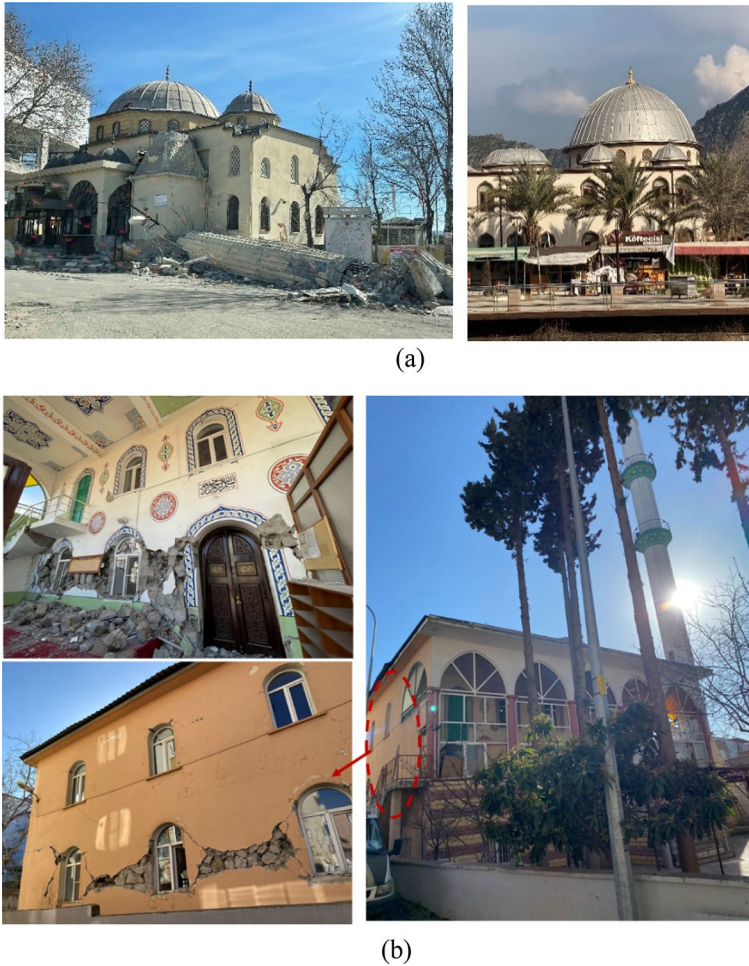
Fig. 36 Damage of mosques **a** Haci Murat Mosque in Kahramanmaraş, **b** Merkez Cumhuriyet Mosque in Pazarcik

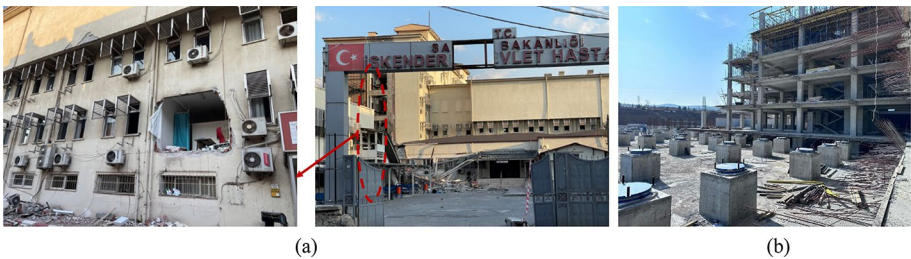
Fig. 38 Hospitals **a** old state hospital in Iskenderun, **b** New city hospital in Malatya
