# The 30 October 2020, $M_w$ 6.6 Sisam (Samos) Earthquake: Interpretation of Strong Ground Motions and Post-Earthquake Condition of Nearby Structures

**Abstract:** A major magnitude  $M_w$  6.6 earthquake struck offshore of the city of İzmir, Turkey and the city of Neon Karlovassion, Greece which has the epicenter located at north of Sisam/ Samos Island in the eastern Aegean Sea on October 30th, 2020. The moment magnitude of the earthquake has been reported variously, such as 6.6, 6.9 and 7.0 by different agencies. Seismic instruments indicate the earthquake originated at a depth of 17.2 and 21 kilometers according to the Disaster and Emergency Management Presidency (AFAD) of Turkey and USGS. Doğanbey Payamlı, Ürkmez, Gümüldür, Kavakdere are the closest coastal villages of İzmir to the epicenter. The earthquake affected the mid-rise buildings located on the soft soil and then, tsunami stroked the coastal villages of İzmir. In this study, the strong ground motion records in a distance range from epicenter to 150 km are analyzed to investigate the characteristic of the ground motions. The post-earthquake field observations mainly for the mid-rise reinforced concrete structures are r

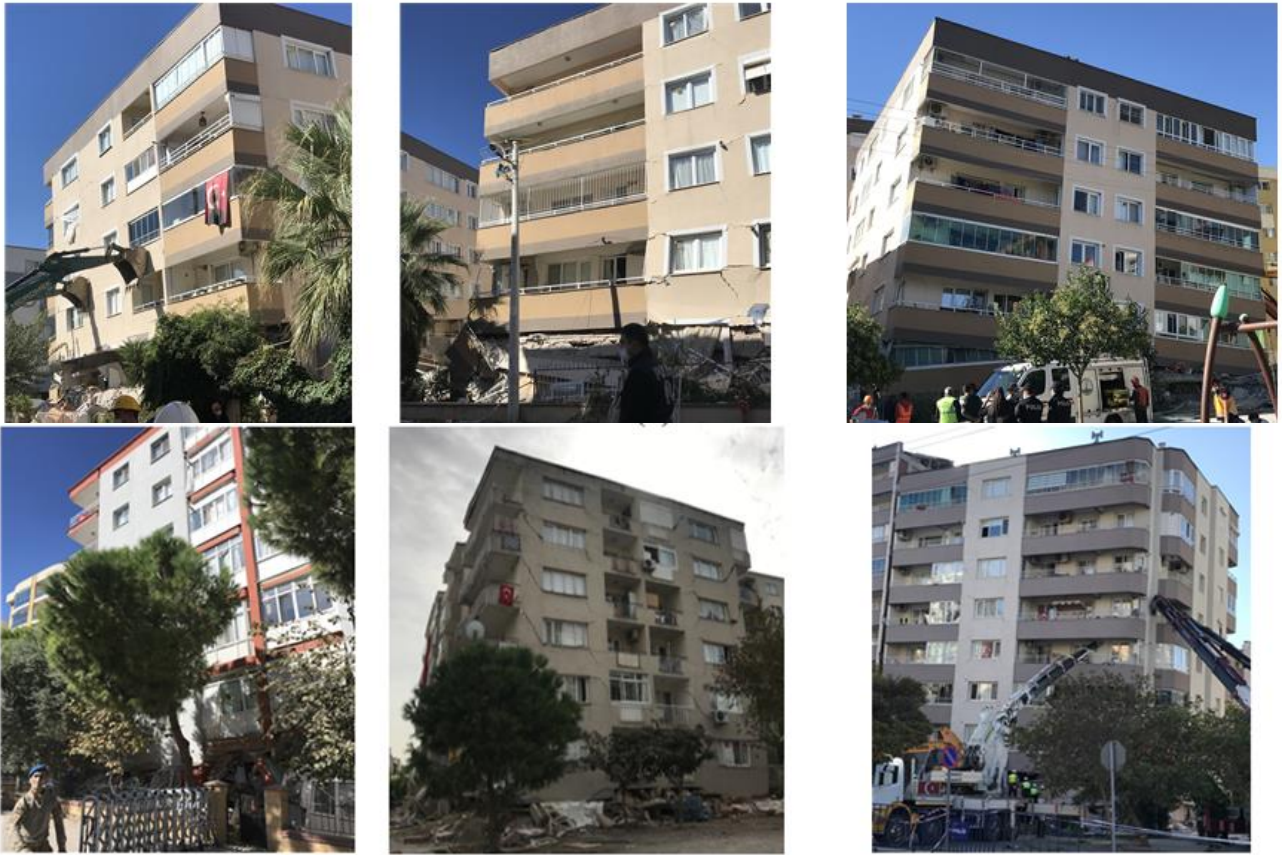
Large openings at the first floor have been used in the buildings for architectural purposes for many decades. Unless specific measures are taken by engineers, first floors typically have lower strength and stiffness due to lack of walls compare to the upper floors. Discontinuity in the structural system results damage concentration at the weaker or more flexible story which is commonly called soft-story mechanism. **Figure 11** shows the buildings that have suffered

extensive soft-story damage/collapse. Large openings on the street side, for store windows or other purposes lead to a significantly weaker and more flexible structural frame than on the other side of the building, which has few openings, and cause topping of the building toward the street side as shown in **Figure 11**.

Figure 11. Partially collapsed buildings due to the soft story mechanism at the first floor in Bornova district in İzmir, Turkey

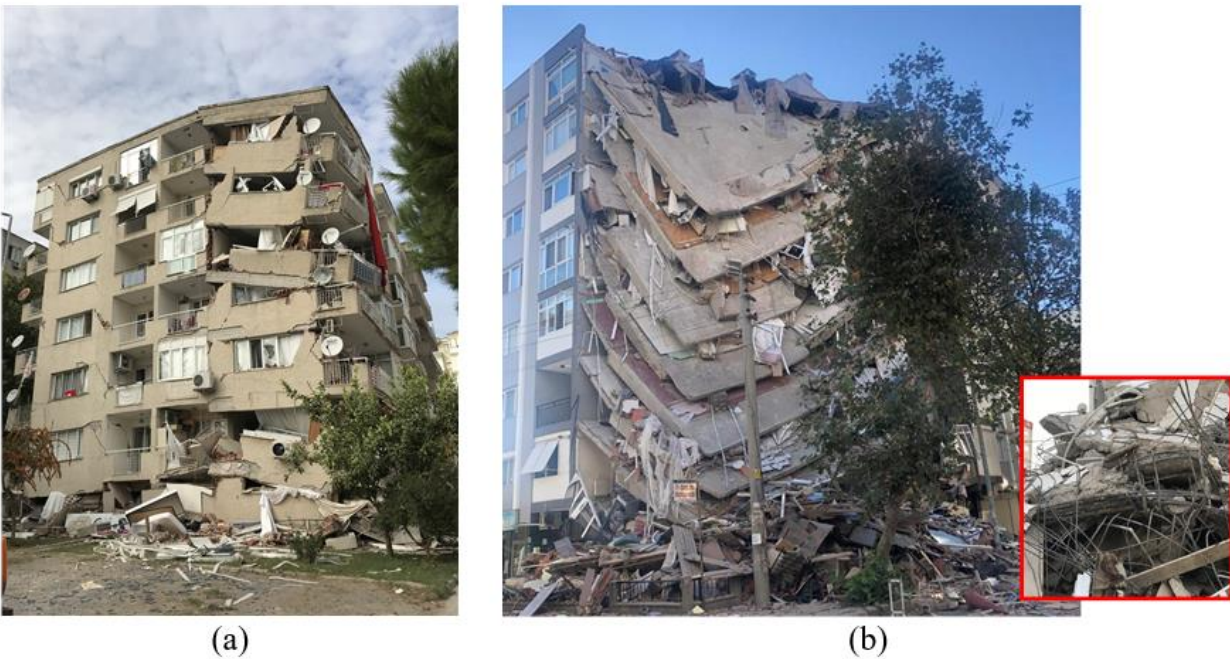
**Figure 12** shows examples of corner column failures. For instance, one quarter of the building was collapsed since it is located on the street corner, thus having two open sides, because of the increased axial and torsional forces at the corner columns during the main aftershock [see **Figure 12(b)**].

Figure 12. Partially Collapsed Building, Located at the Street Corner

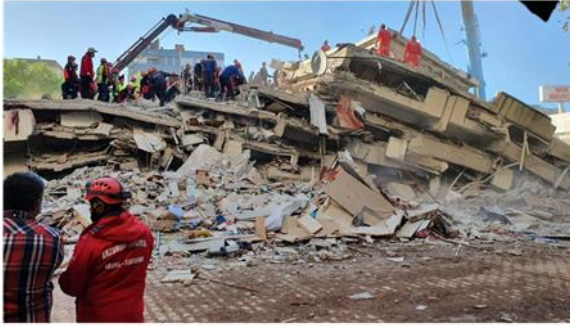
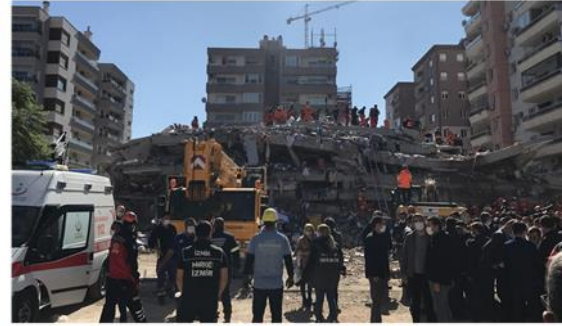
Structures are allowed to be damaged at a certain level under the strong ground motions however these damages expected to be occurred at the end of the beams rather than the columns for ductile behavior in moment frames not to lead collapse. To be able to fulfill this requirement, the ultimate strength of the columns should be greater than the beams at the joints. Field observations showed that weak column strong beam (WCSB) systems are common in İzmir, Turkey might have resulted in numerous story collapses, following excessive column damage as shown in **Figure 13**.

**Figure 13.** Damage due to Weak Column Strong Beam (WCSB) Ratio

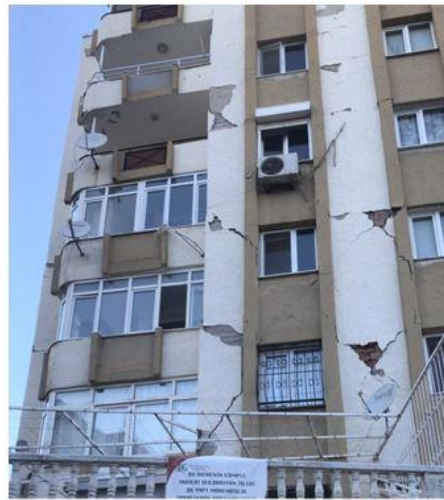
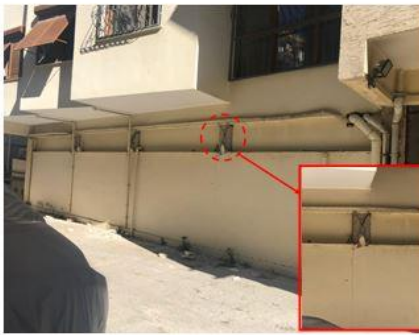
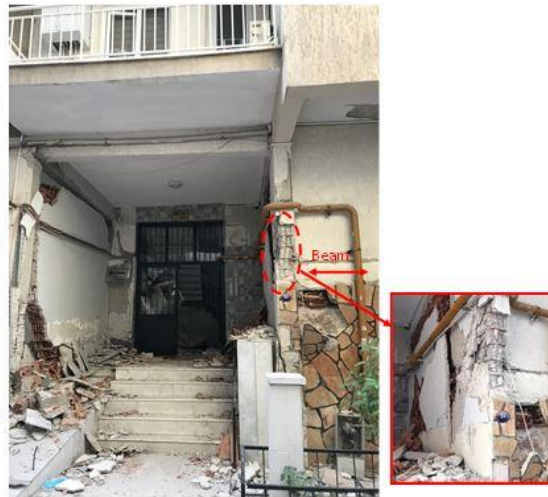
Another common type of column damage was observed when partial height nonstructural partitions were used in the buildings as shown in **Figure 14(a)**. **Figure 14(b)** and **(c)** also shows the short column effects that observed in the field. These partitions or presence of subbasement [**Figure 14(c)**] prevent the development of the column's actual flexural behavior over the height, rather allow them to deform over the free height. Even though, these short parts of the column would make it possible to resist higher lateral forces before the flexural strength of the column is reached, the shear strength of a short column is often first reached and typical non-ductile shear failures occurs.

**Figure 14.** Short column due to presence of lower grade floors.

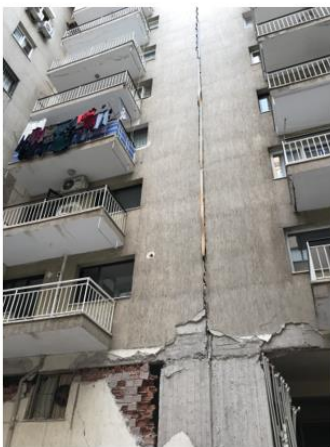
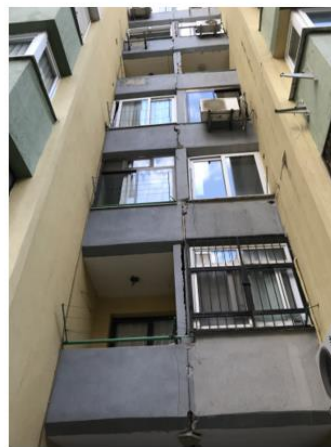
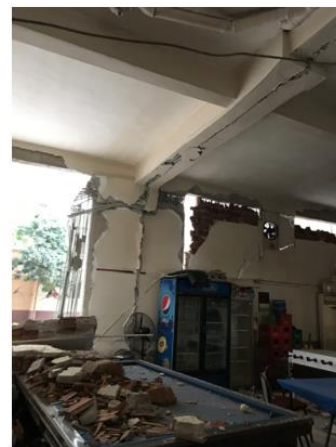
**Figure 15.** Inadequate Earthquake Joints in Bayraklı district of İzmir, Turkey

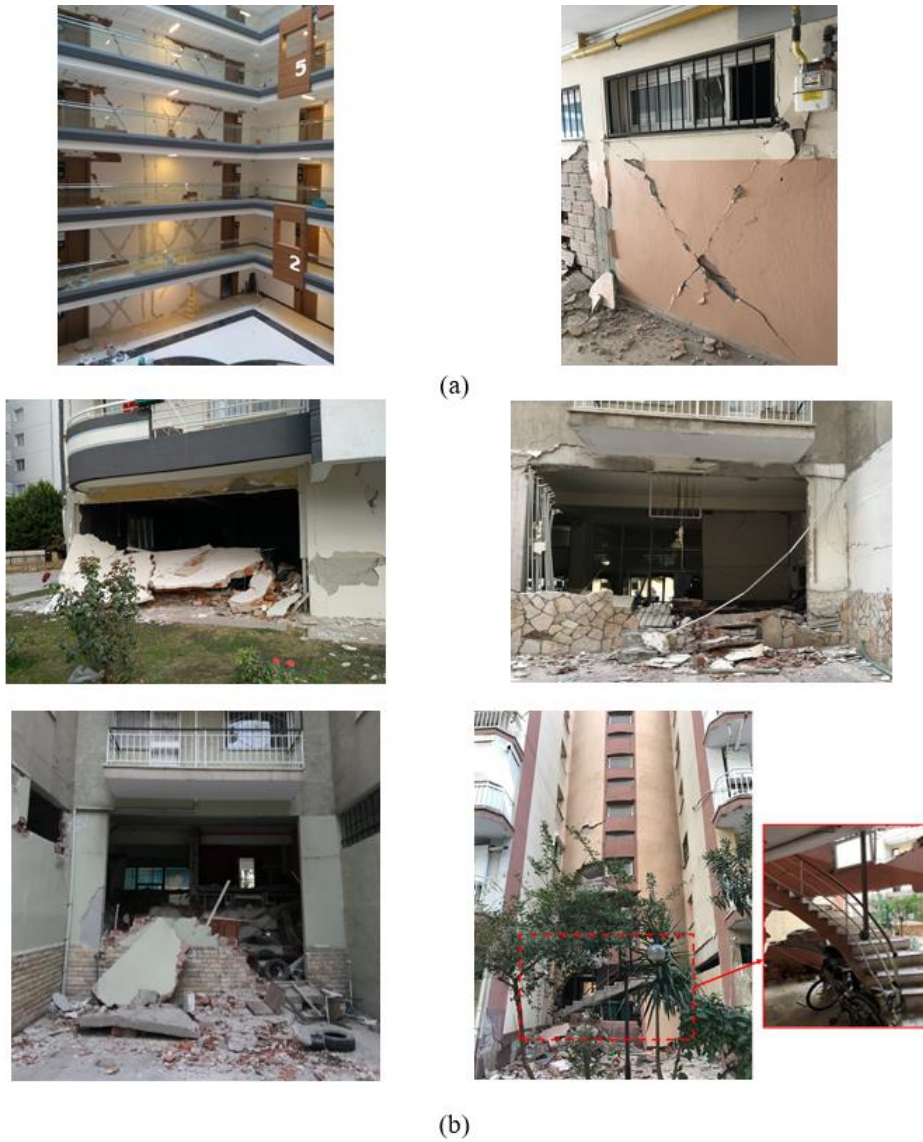
**Figure 16.** Damage of Infill Walls

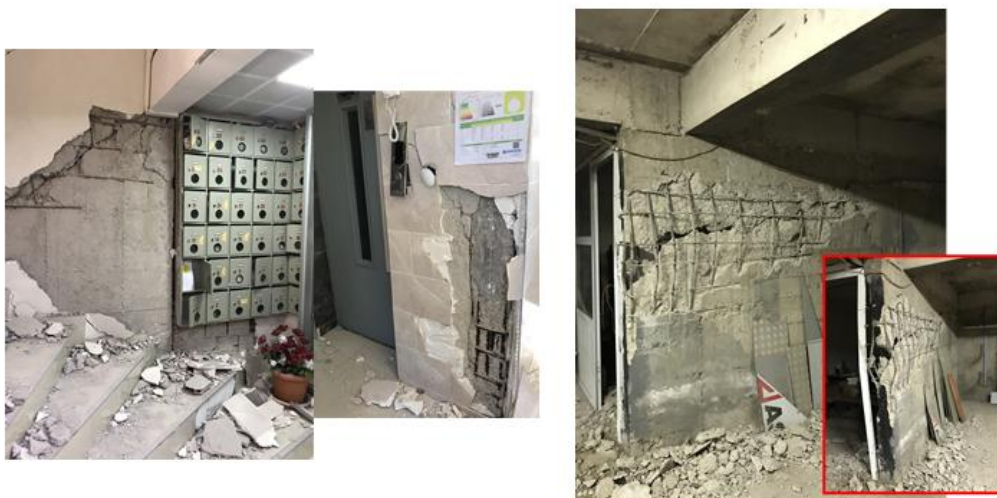
**Figure 17.** Buckling of Distributed Vertical Reinforcement in Shear Walls

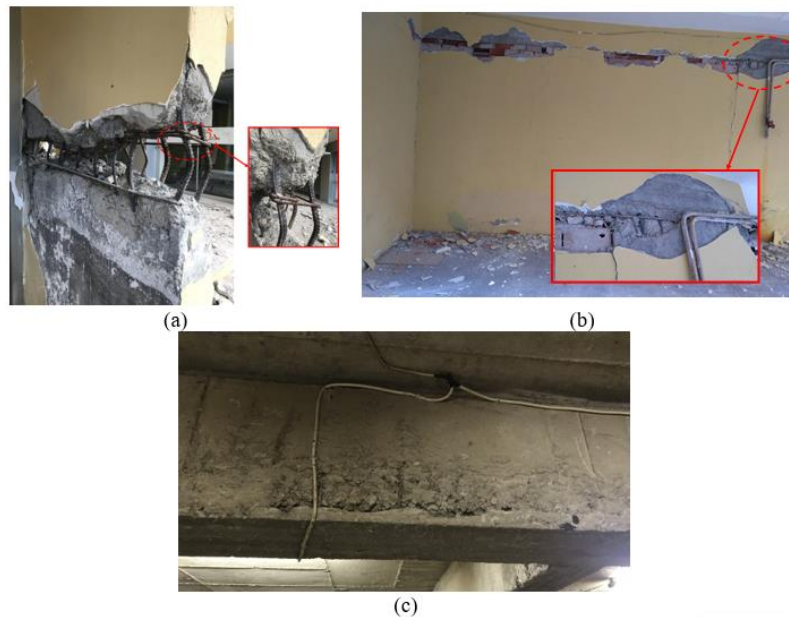
Detailing of reinforcement is very important for the deformation of the buildings. **Figure 18(a)** shows how widely spaced ties with 90° bent hooks were insufficient to contain the damaged concrete and prevent vertical bars from the buckling. Poor formwork installation was observed in many buildings in Bayrakli and Manavkuyu districts of İzmir as shown in **Figure 18(b)**. Misalignment of the formwork caused cracking and structural damages in many columns and shear walls in the structure. Poor quality concrete and concrete materials were also observed in many buildings in İzmir, Turkey. This situation resulted in the concrete to exhibit an excessive porous structure **Figure 18(c)**. Formation of cold joints were observed in many buildings where the cracks were occurred at these points [see **Figure 18(b)**].

**Figure 18.** Defects due to Formwork Installation, Poor Concrete Quality and Workmanship

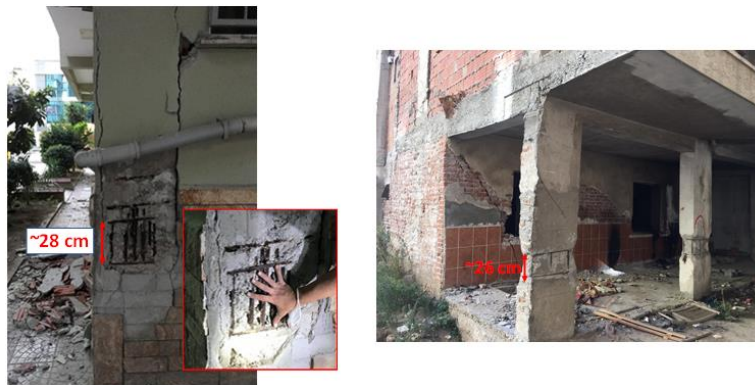
**Figure 19.** Inappropriate Reinforcement Spacing and Excessive corrosion in the reinforcement

**Figure 19** illustrates the reinforcement spacing which exceeds the maximum spacing requirements and inadequate confinement reinforcement. Corrosion in reinforcements took place due to insufficient concrete cover and low quality of the concrete. It was also observed that the anchorage and lap splice lengths were not properly taken care of in many severely damaged buildings as shown in **Figure 20** and **Figure 21**.

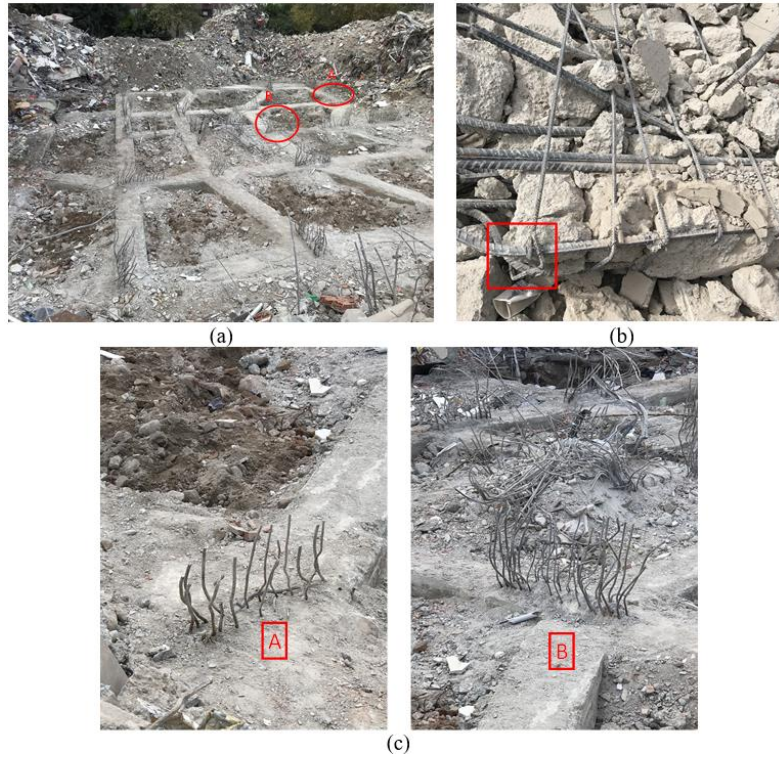
**Figure 20(c)** shows the lap splice lengths which varies through the foundation. Inadequate lap splice length and straight ends of these laps poorly affects the overall behavior of the columns. Similar to many other buildings, improper hook detailing in stirrups was also observed as shown in **Figure 20(b)**. Irregularities and deficiencies at the structures also caused problems at the overall behavior of structure as shown in **Figure 22**.

**Figure 20.** Inadequate lap splice length example from a collapsed building at major strike.

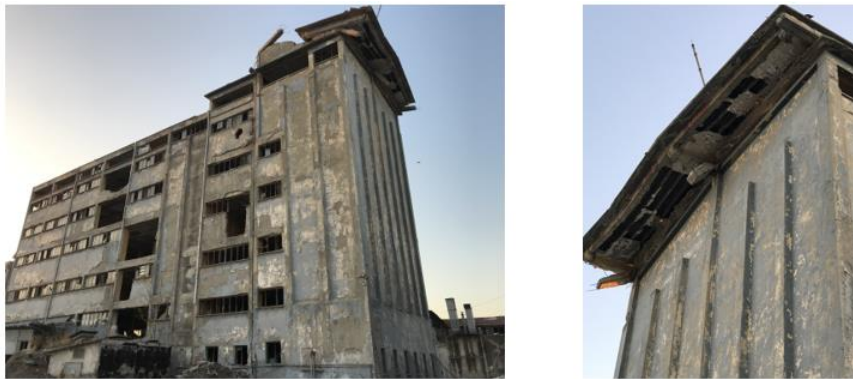
**Figure 21.** Damage of Abandoned Factory

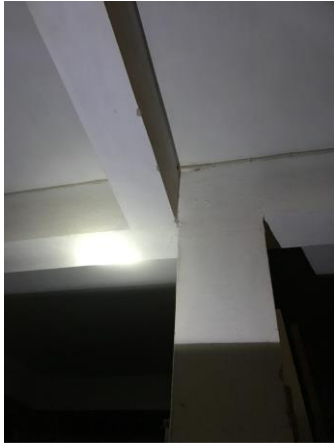
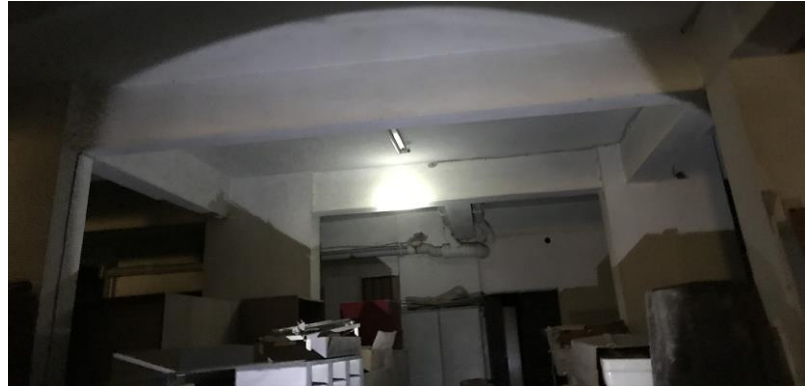
**Figure 22.** Frame Deficiencies and Irregular Floor Layout

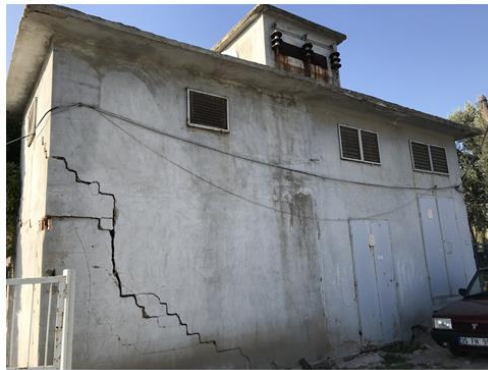
**Figure 23.** Damage at the corner of the masonry power distribution unit

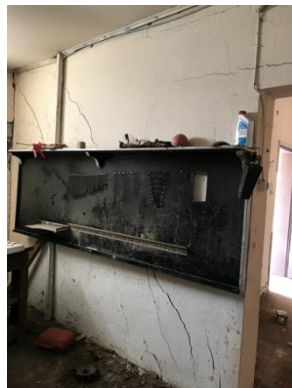
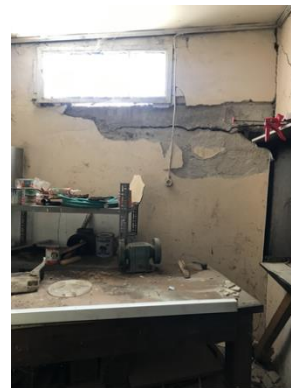
Lack of connection between the orthogonal walls in masonry structures may cause damages if these walls do not share some bricks to act together (Kaplan et al., 2008). One common place of the failure is the corners as shown in **Figure 23**. Dimensions and location of the openings in masonry structures were limited by the seismic designed codes since they reduce the area of the load bearing walls. Cracks due to large openings in the walls or windows too

close to the corners were observed at some of the university campus buildings as shown in **Figure 24** through **Figure 26**.

**Figure 24.** Machine shop of Department of Agriculture at Ege University

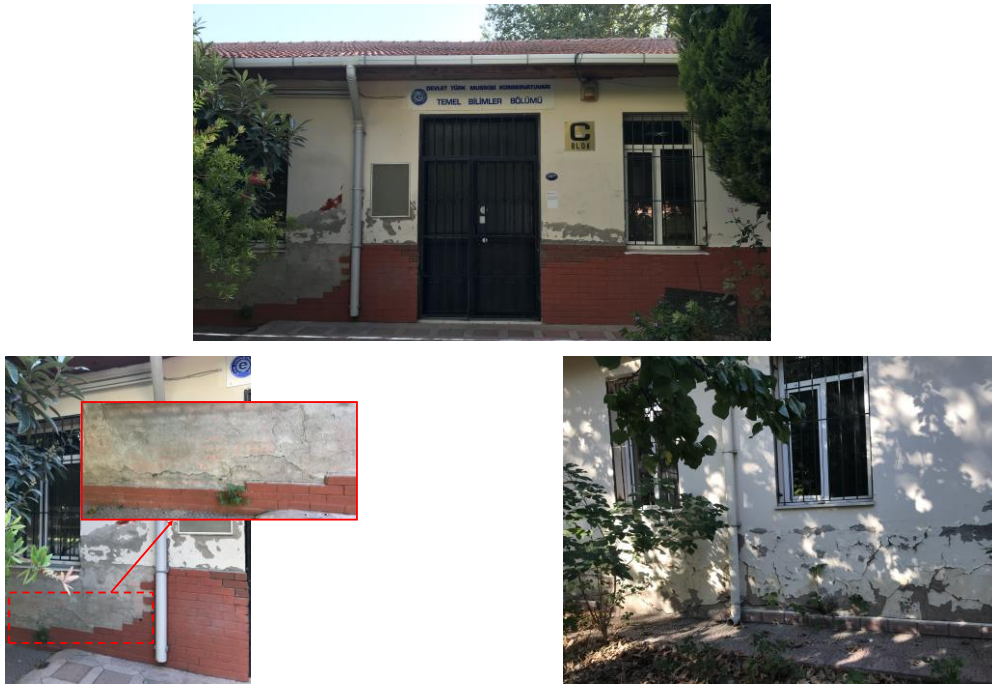
**Figure 25.** School of Conservatory at Ege University

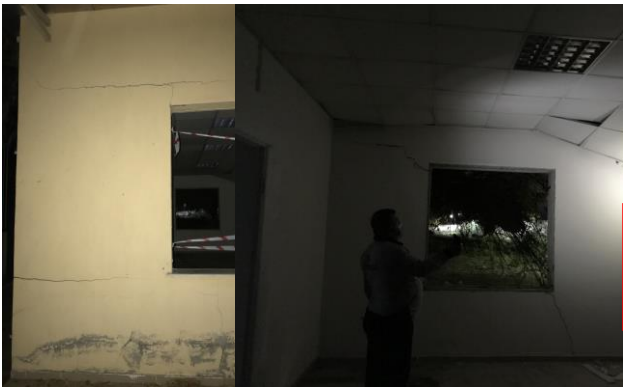
**Figure 26.** School of Medicine Classrooms at Ege University Steel Structure

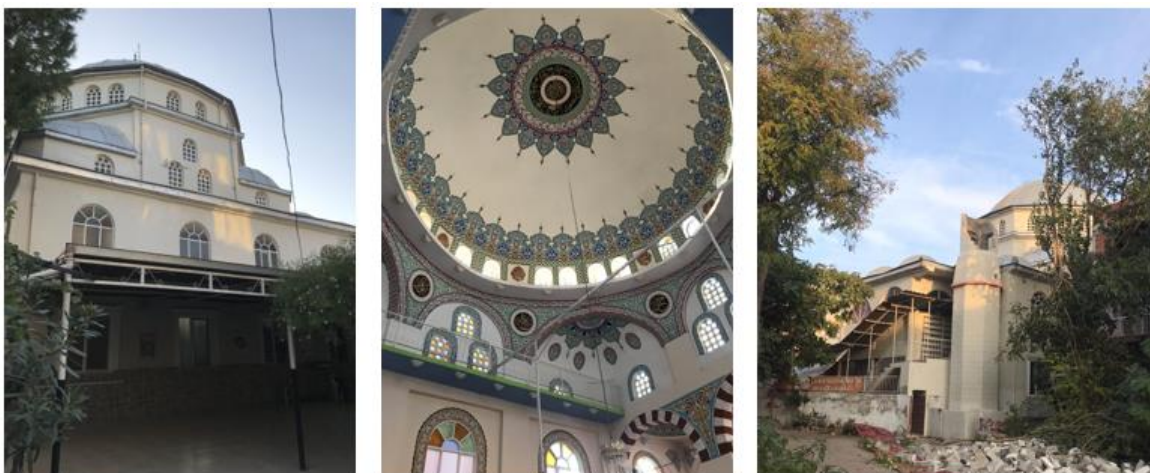
Soil supporting foundations may undergo consolidation or shear failure when subjected to excitation during an earthquake, leading to ground settlement or subsidence. The ground settlement can cause buildings to displace which may lead damages in the masonry walls as shown in **Figure 26**. The nonstructural damage was also observed. The most vulnerable top part of minaret of a mosque was collapsed while the remaining of the mosque was not even damaged. The minaret is connected to the mosque at the two story level and this creates a stiffness and boundary variation in the height and result in cracks usually at the points with abrupt cross-sectional changes which leads the minarets collapse. **Figure 27** shows the partial collapse of the minaret from the part this cross-sectional change starts.

**Figure 27.** Damage of Mosque at the Upper Part of Minaret

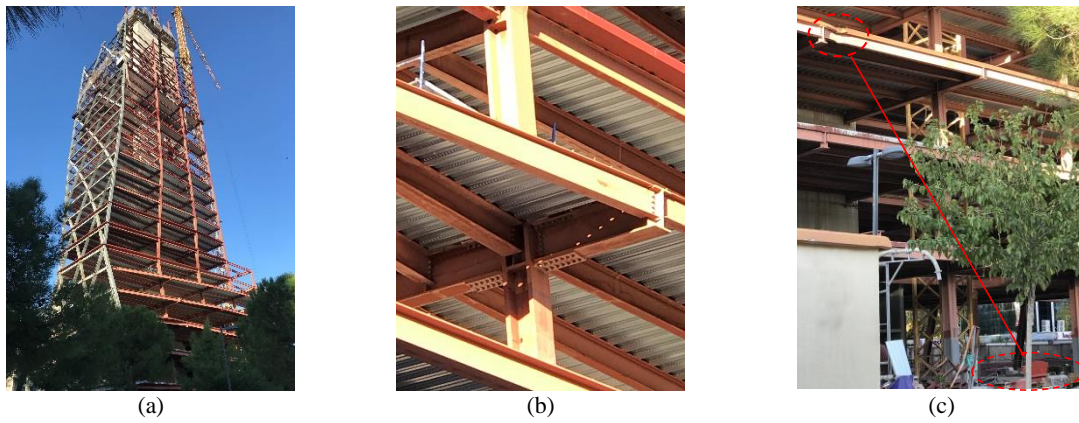
In Izmir, only few buildings were constructed by using structural steel. **Figure 28(a)** shows the steel structural building with a reinforced core in the middle which was under construction when the earthquake hit the city. Before the earthquake, most of the steel frames in the buildings was completed but all the steel beam-to-column joints were visible during the earthquake. Following the earthquake, there was no connection damages on the beam to column junctions as shown in **Figure 28(b)**. However, the column at the last floor which was temporarily attached to the underneath column was collapsed and caused damage to some beams at the third floor as shown in **Figure 28(c)**.

**Figure 28.** a) Steel Building under Construction b) Beam-to-column joints, c) Damage at the third floor beam due to collapse of a column at the construction level.

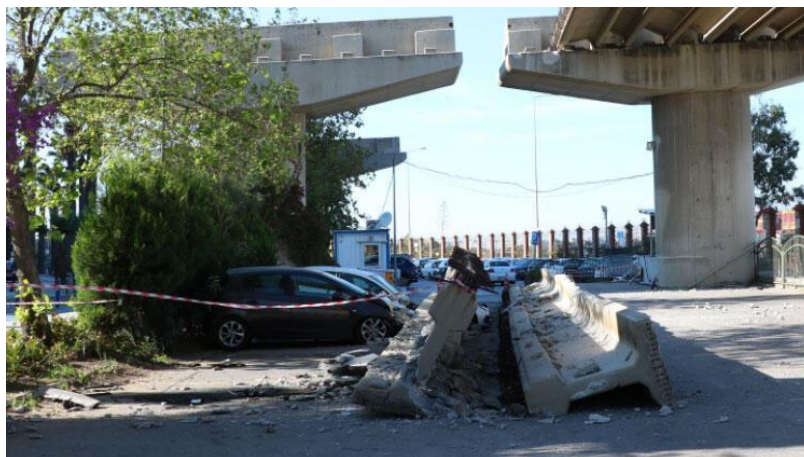
**Figure 30.** a) Girder fall from unfinished bridge viaduct construction in Alsancak due to no lateral connection detailing (Photo is adapted from <https://i4.hurimg.com/i/hurriyet/75/0x0/5fa6a9f00f254410e87185f2> )
