# The 30 October 2020, $M_w$ 6.6 Sisam (Samos) Earthquake: Interpretation of Strong Ground Motions and Post-Earthquake Condition of Nearby Structures

**Abstract:** A major magnitude  $M_w$  6.6 earthquake struck offshore of the city of İzmir, Turkey and the city of Neon Karlovassion, Greece which has the epicenter located at north of Sisam/ Samos Island in the eastern Aegean Sea on October 30th, 2020. The moment magnitude of the earthquake has been reported variously, such as 6.6, 6.9 and 7.0 by different agencies. Seismic instruments indicate the earthquake originated at a depth of 17.2 and 21 kilometers according to the Disaster and Emergency Management Presidency (AFAD) of Turkey and USGS. Doğanbey Payamlı, Ürkmez, Gümüldür, Kavakdere are the closest coastal villages of İzmir to the epicenter. The earthquake affected the mid-rise buildings located on the soft soil and then, tsunami stroked the coastal villages of İzmir. In this study, the strong ground motion records in a distance range from epicenter to 150 km are analyzed to investigate the characteristic of the ground motions. The post-earthquake field observations mainly for the mid-rise reinforced concrete structures are r

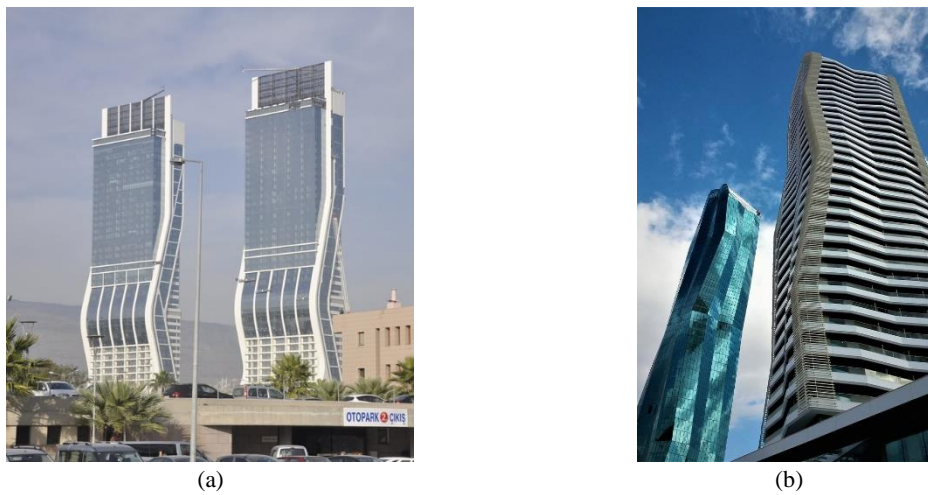
**Figure 29.** a) Folkart Towers b) Mistral Tower

good performance except few of them which have excessive non-structural damages. The main reason of having less damage in tall buildings is considered as strong foundations with ground improvement with piles. In **Figure 29**, two remarkable tall buildings, which are Folkart Towers and Mistral located in Bayraklı are given. These two towers showed good performance at main shock and have no significant structural damage. In **Figure 30**, the only damage occurred in bridges/viaducts has been showed. The viaduct is an unfinished construction more than 10 years and the fall of the girder was the result of no lateral support connection detailing.
